Visual Roof Inspection Report

Food Lion Store #:
1458

30214 Sussex Hwy
Laurel
DE
19956

04/02/2019

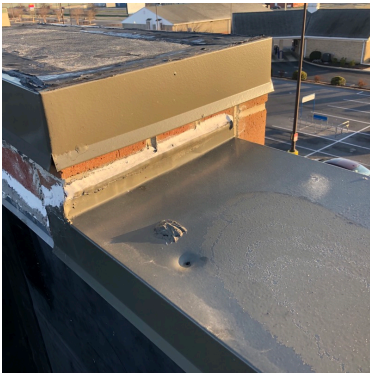
Item	\$0.00
Section A: 1	Hole in Coping	Apply sealant	C

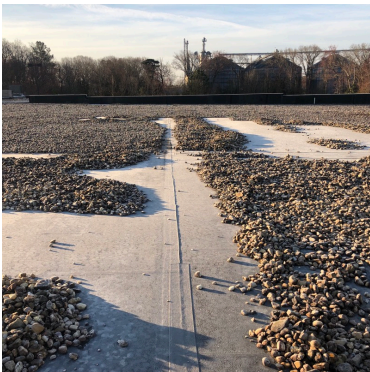
1	Item	\$150.00
Section A: 2	Displaced Ballast	Disperse piles throughout bare areas	C

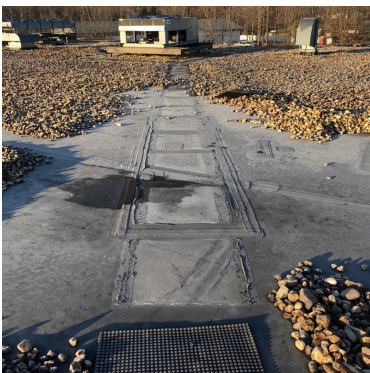
3000	SQ FT	\$1,050.00
Section A: 3	Delaminated Walkway	Dispose of loose and install new	2
