FOOD LION #1458 REVISED DRAIN SURVEY PER ENGINEERING REVIEW;
6/6/19 5/30/2018 - 6/6/2019

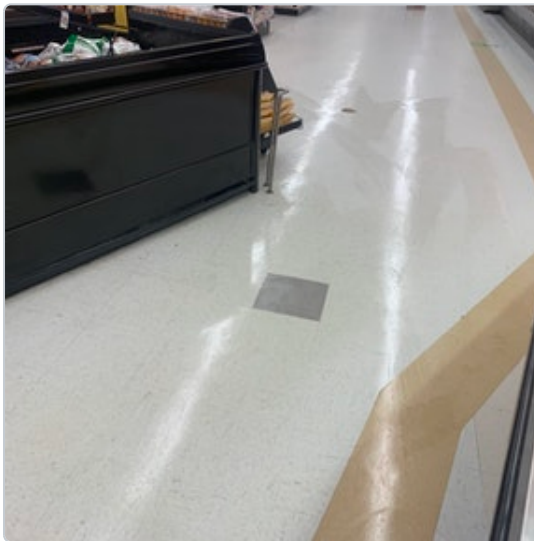
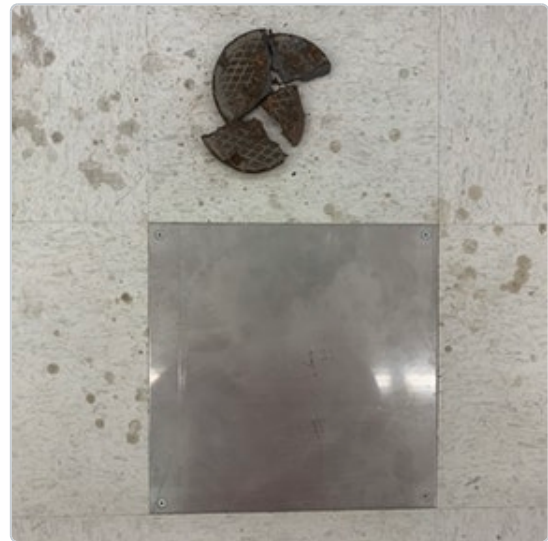
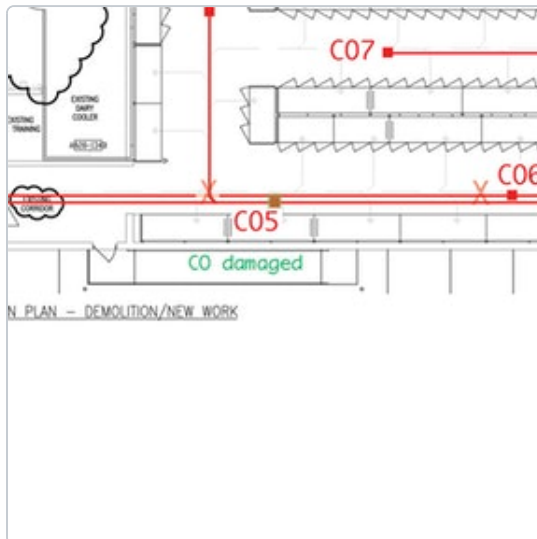
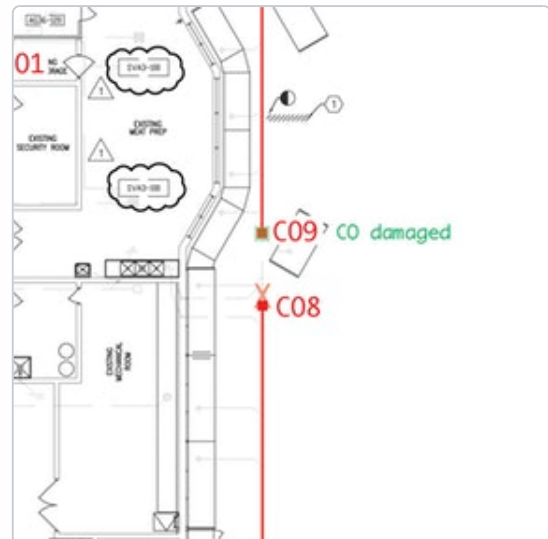
Post 3 - C05 and C09 - Cleanout weights were broken while accessing.

Per email from Food Lion Engineering on 6/6/19, item is to be included in remodel documents.

Replace the entire cleanout fixtures.

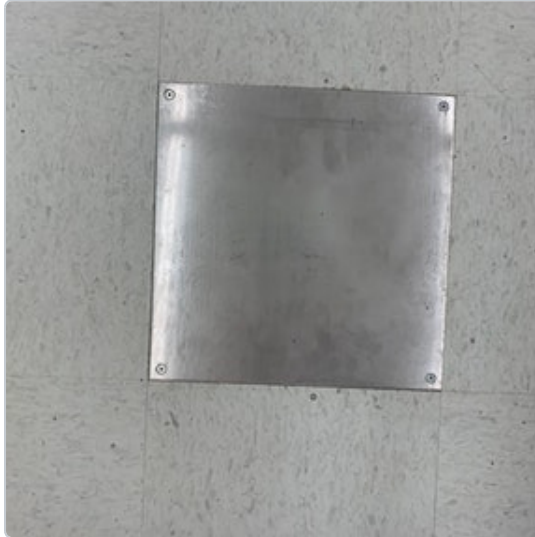
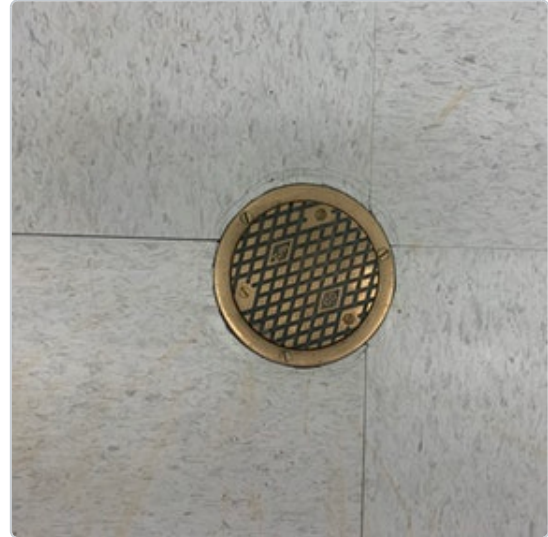
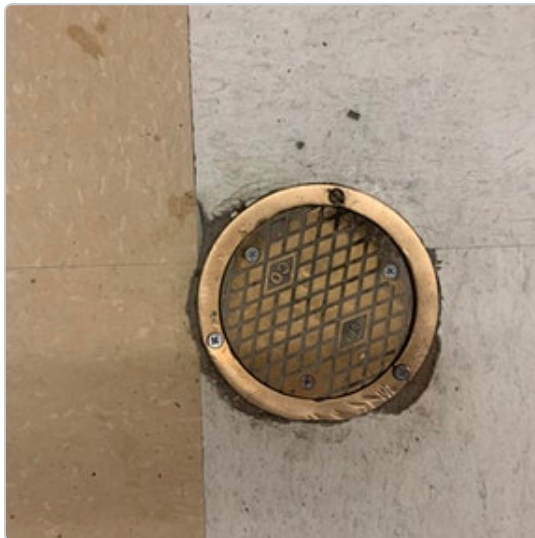
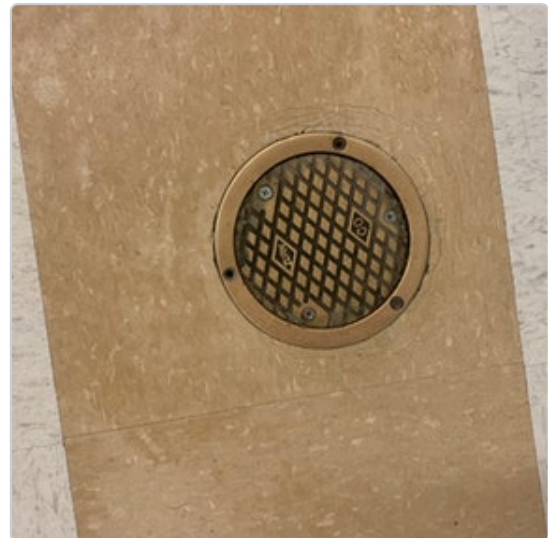
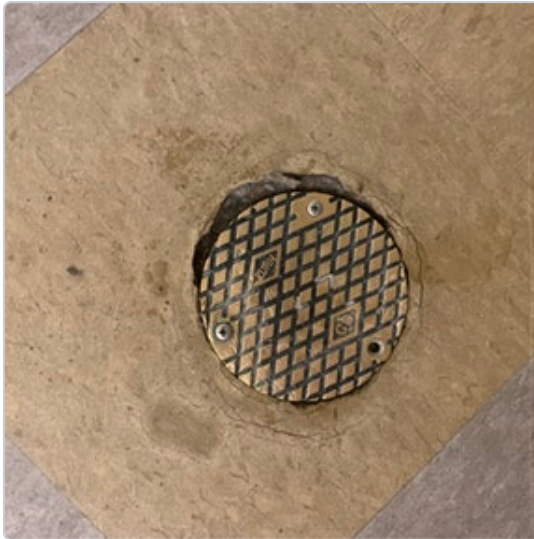
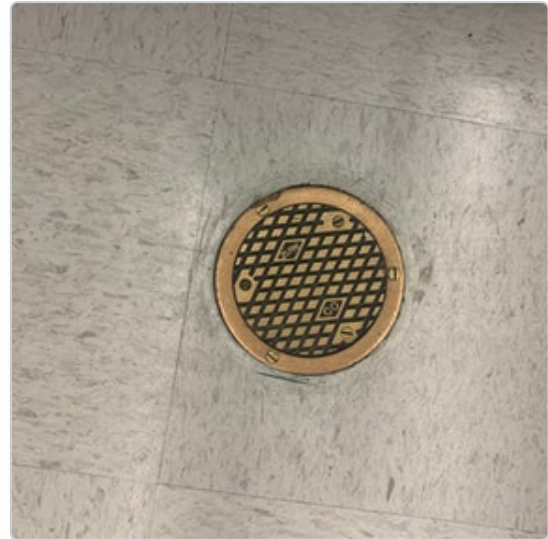
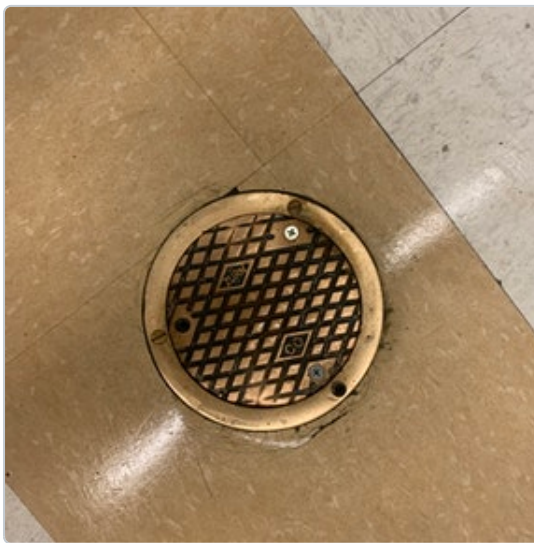
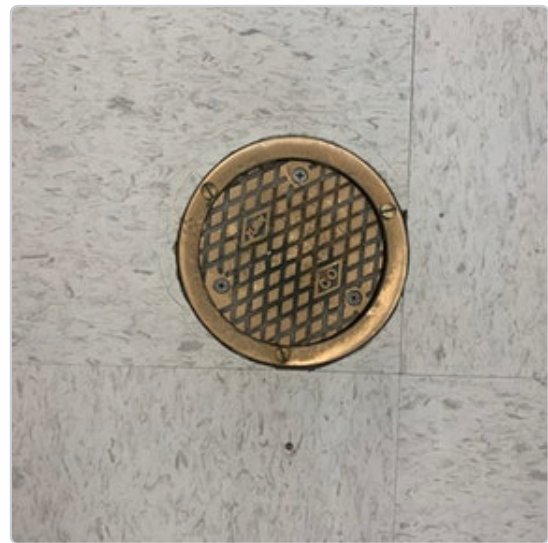
**Unassigned****Post 4 - Construction Manager to review cleanouts for possible repair (for reference)**

The sales floor cleanouts typically have surrounding tile damage / unlevel / should be cleared of excess wax and debris. Ensure all are level with finish floor upon closeout of remodel. Consider replacing fixtures.

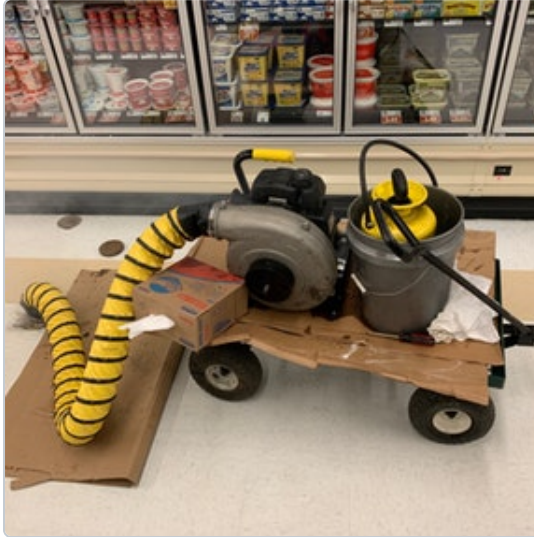
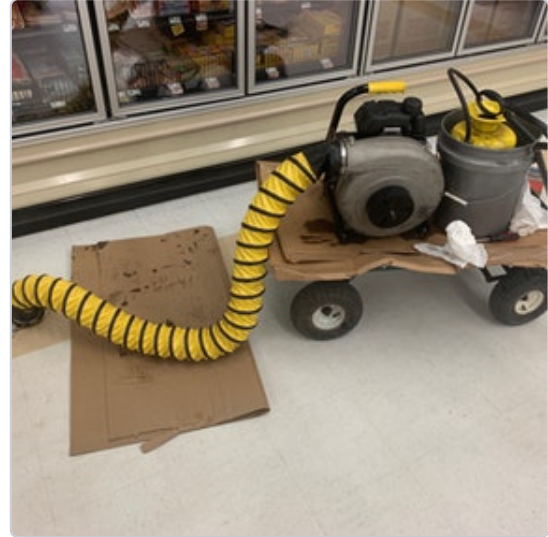
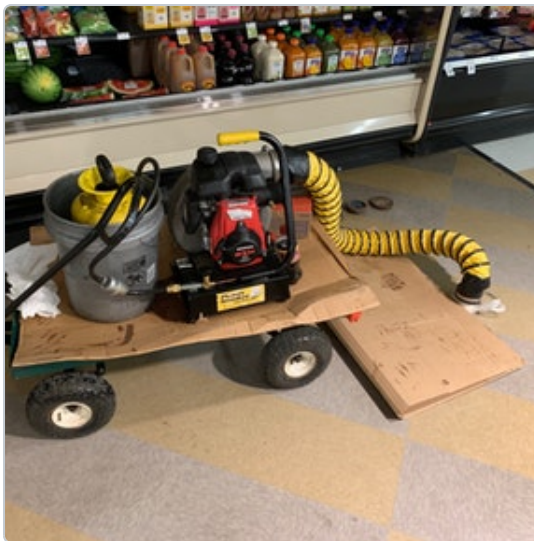
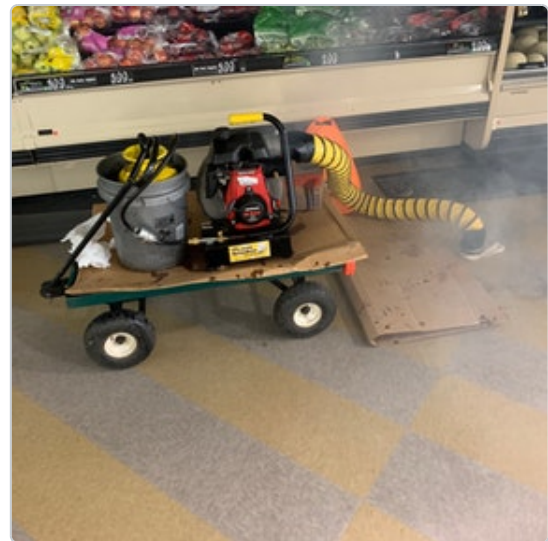
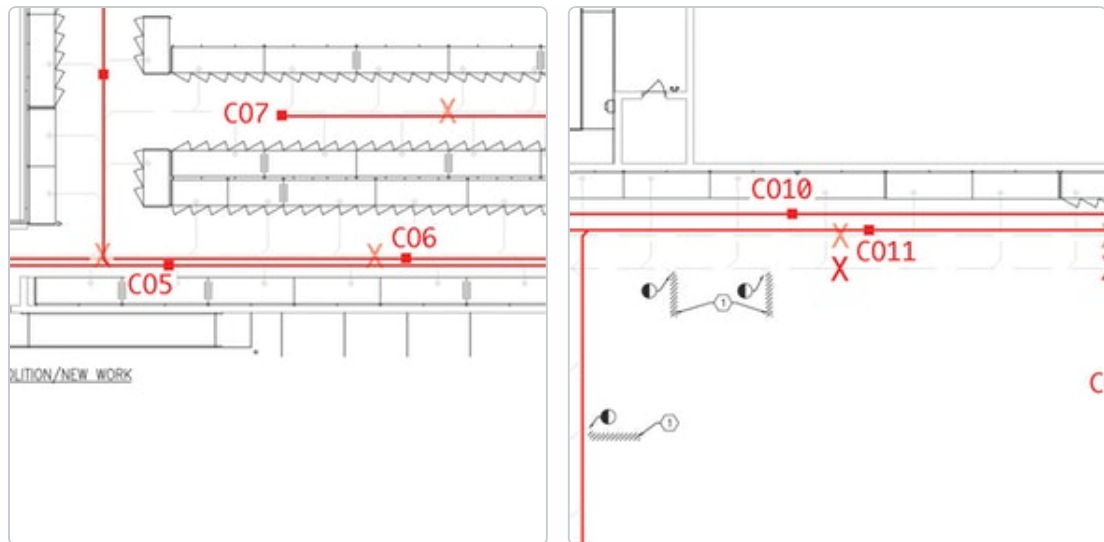
Unassigned**Post 6 - Smoke test performed from cleanouts CO5, CO6, CO10 and CO11 - 03/11/2019**

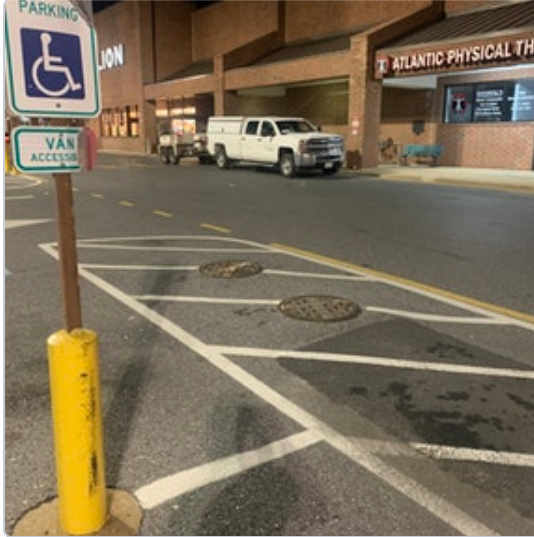
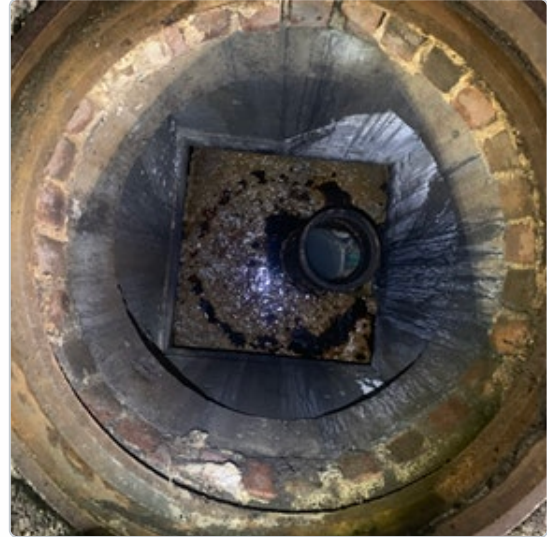
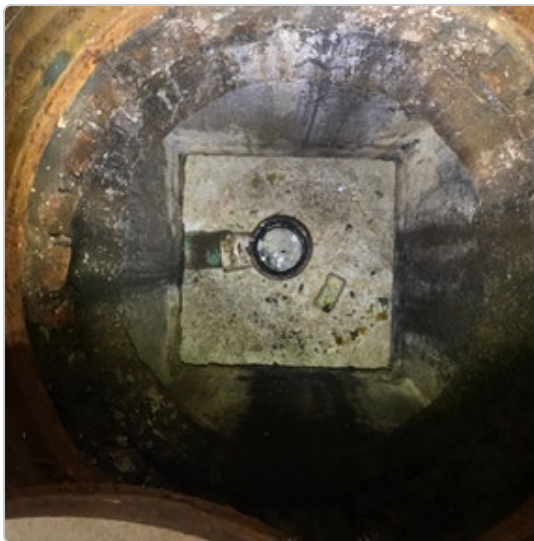
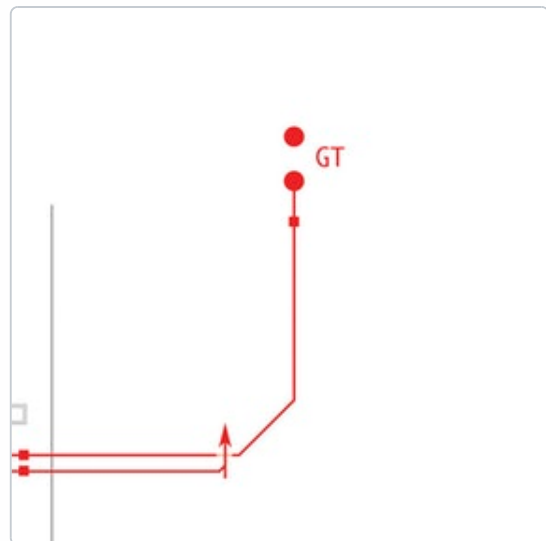
Post 9 - Grease trap - Appears to be functioning normally with inlet 1/2" above outlet.

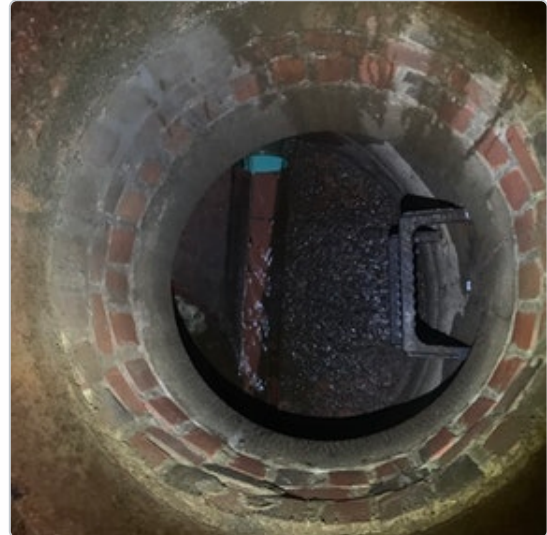
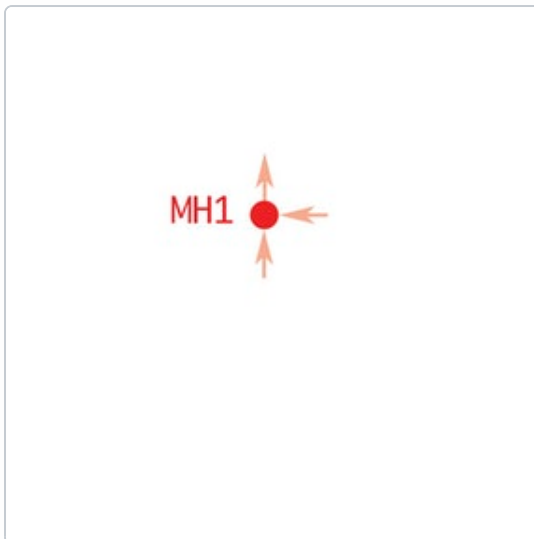
Unassigned**Post 27 - Manhole MH1**

Manhole is flowing/operating normally.

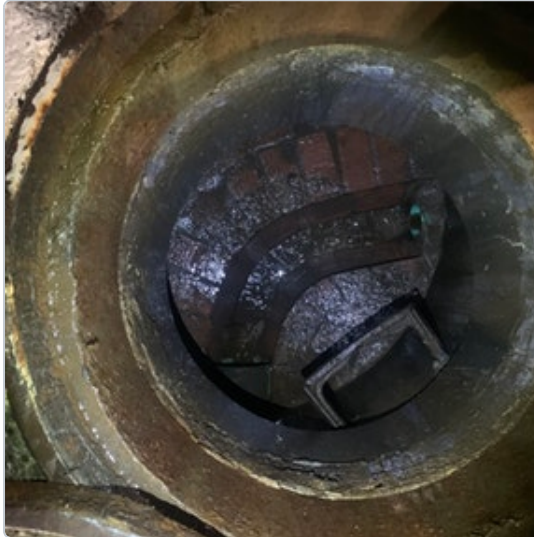
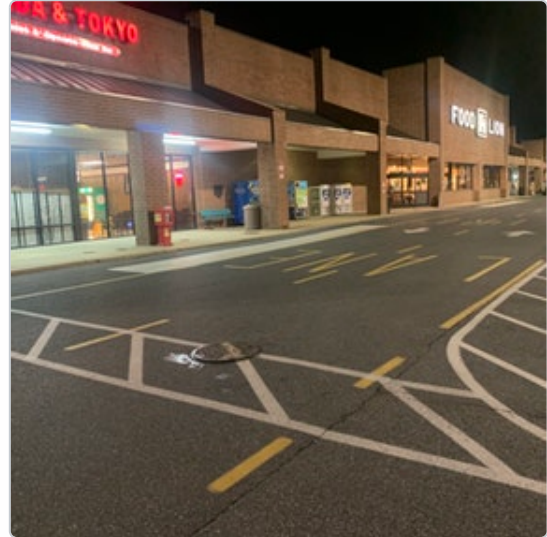
Unassigned**Post 14 - Manhole MH2**

Manhole is flowing/operating normally.

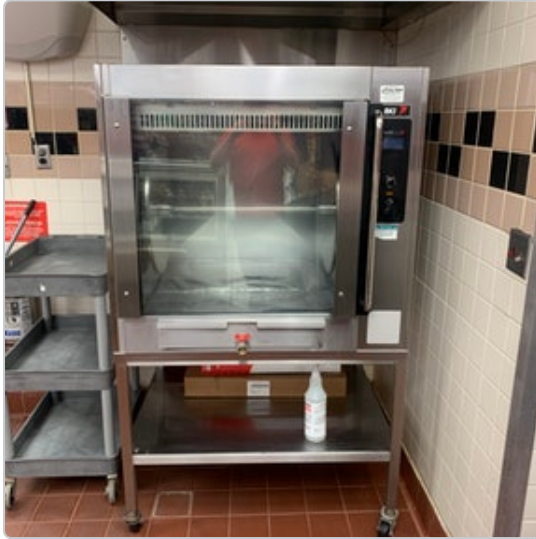
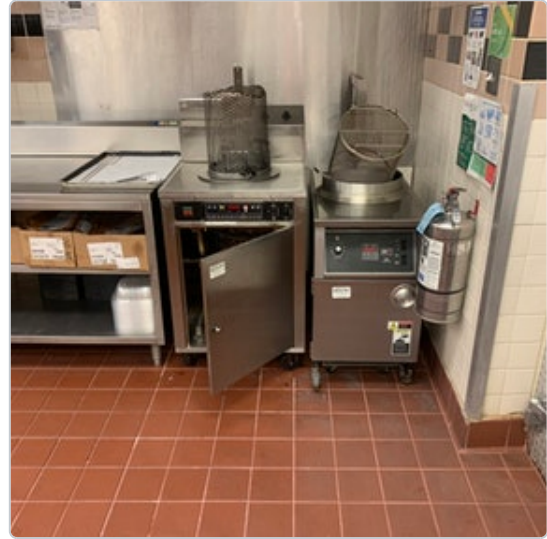
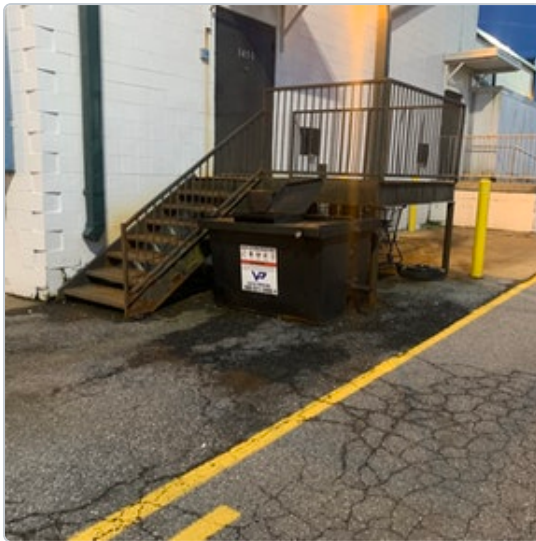
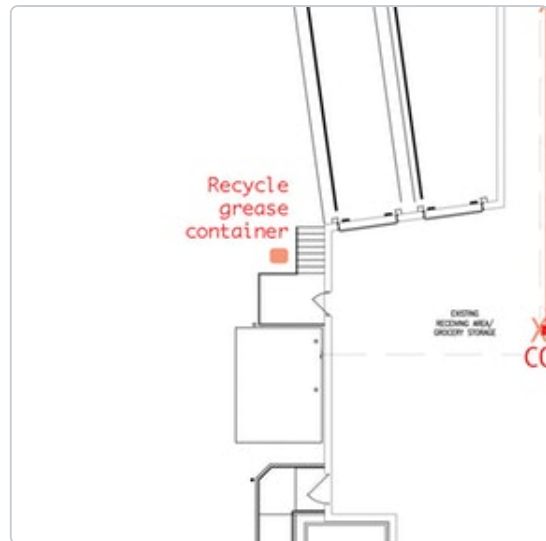
Unassigned**Post 11 - Deli Equipment**

Recycle grease container verified to be onsite.

Rotisserie and fryers appear to be manually emptied.

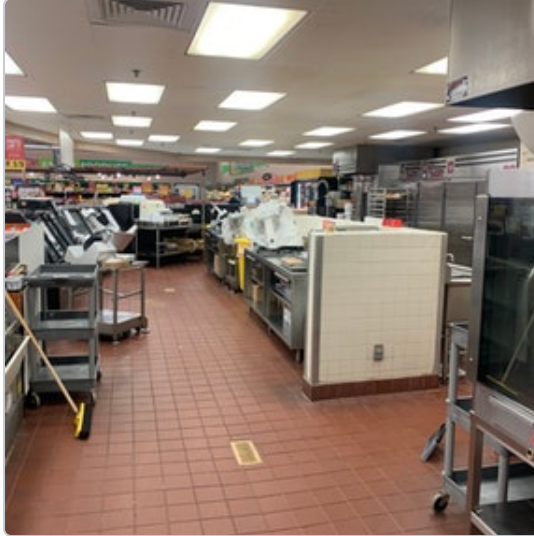
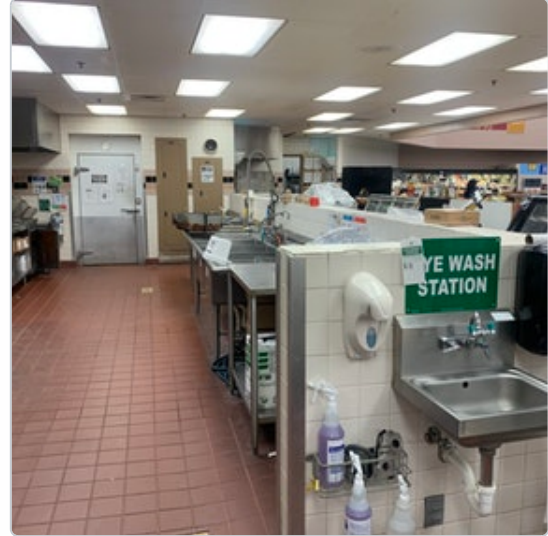
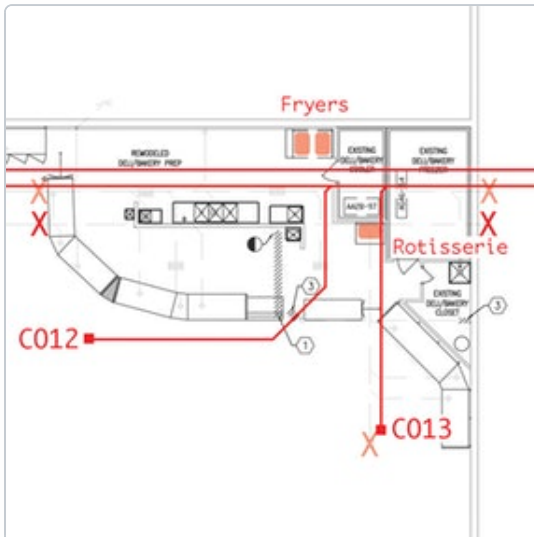
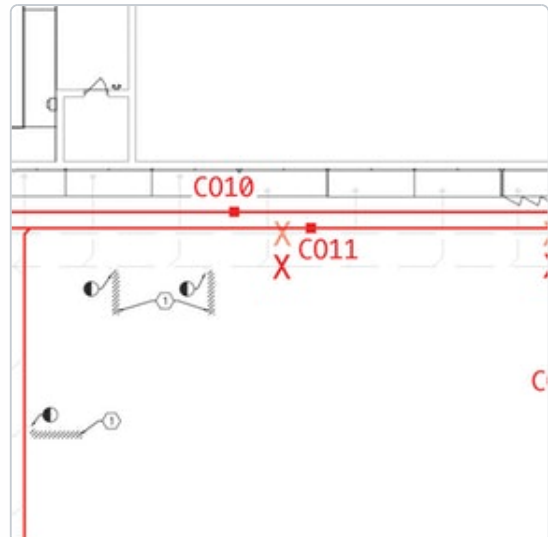
Unassigned**Post 13 - Deli grease drain - prep area verifications**

The deli prep area floor drains, prep sinks, and mop sink were confirmed to go to CO10 line.

All grease prep area sinks and drains were confirmed to go to the existing grease trap.

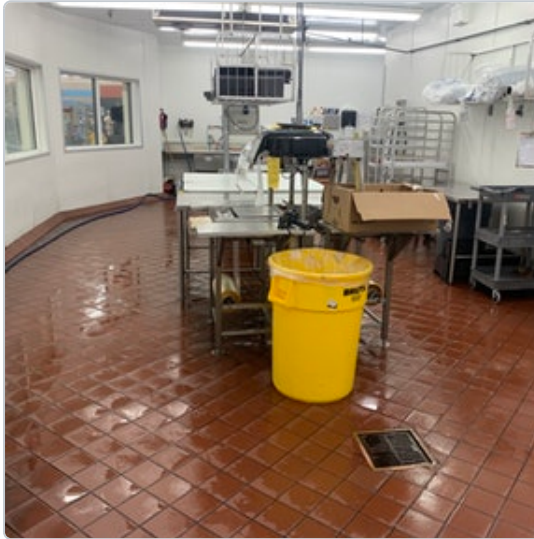
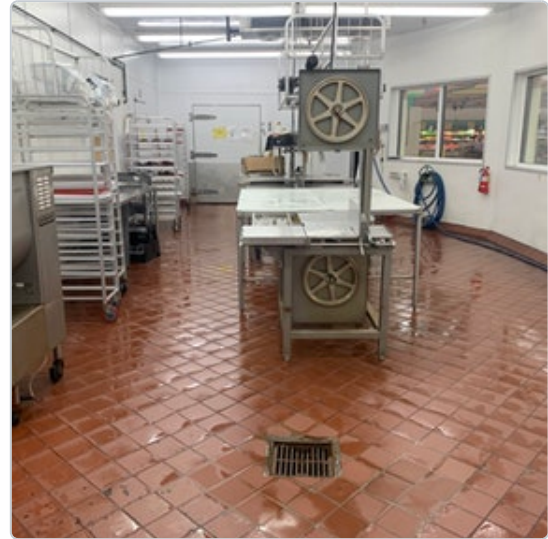
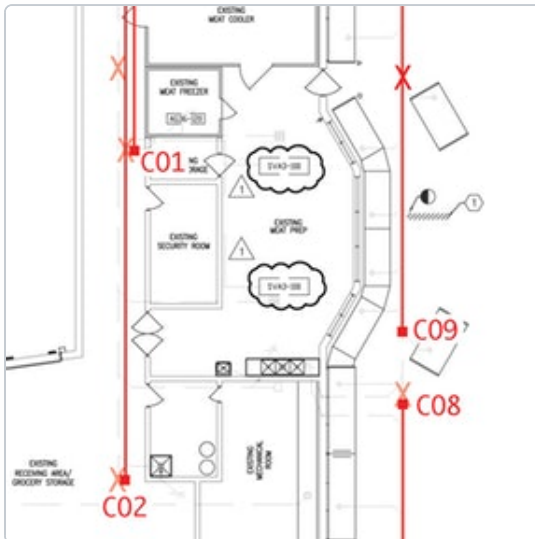
Unassigned**Post 12 - Meat grease drain - prep area verifications**

The meat prep area floor drains, three-compartment sink, and grocery storage mop sink were confirmed to go to CO2 line.

All grease prep area sinks and drains were confirmed to go to the existing grease trap.

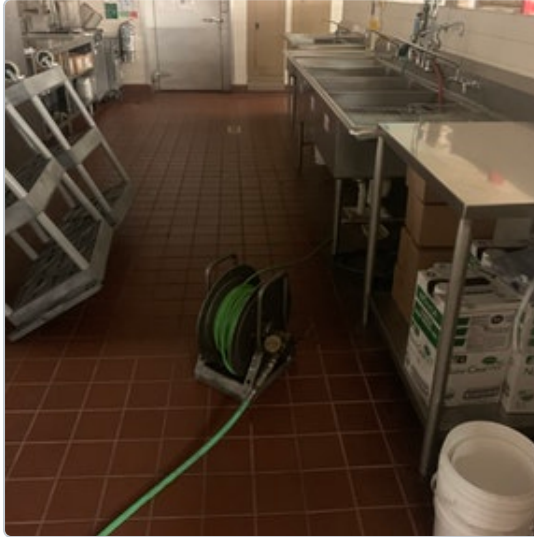
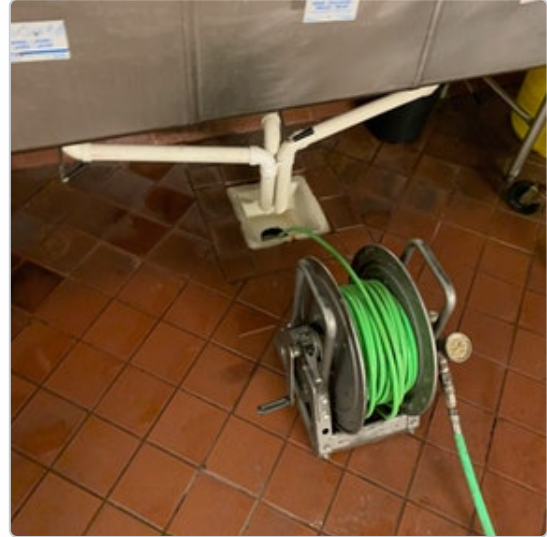
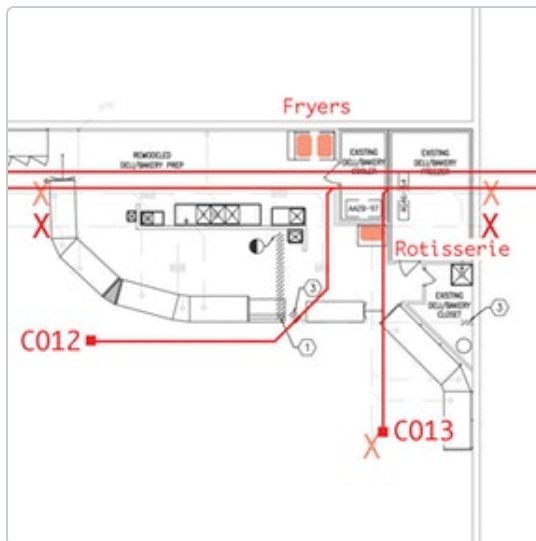
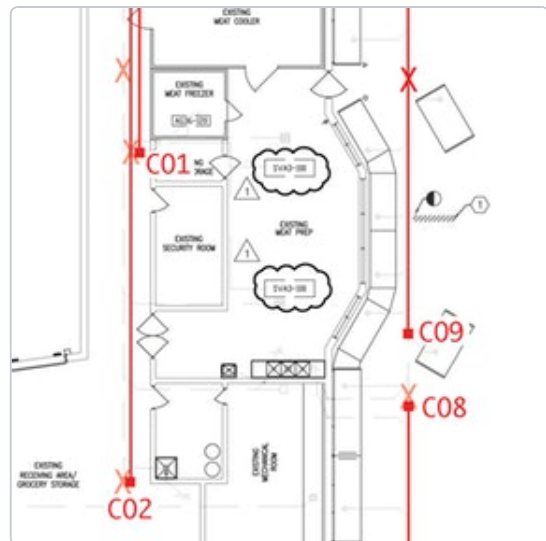
Post 10 - All individual prep area grease waste drains were cleaned with mini jet kit.

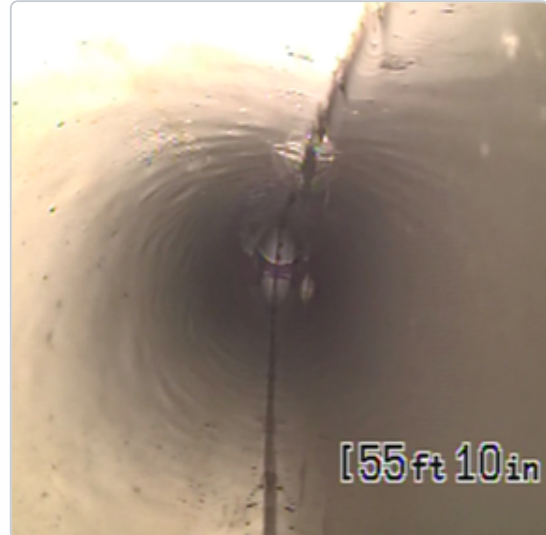
**Unassigned****Post 26 - CO1 video (for reference)**

CO1 line: Invert elevation is 30.5" BFF. Jetted line. Filmed backwards from CO11. Two back-to-back sags from 55' to 117' (2"+, with camera underwater most of issue). Sag from

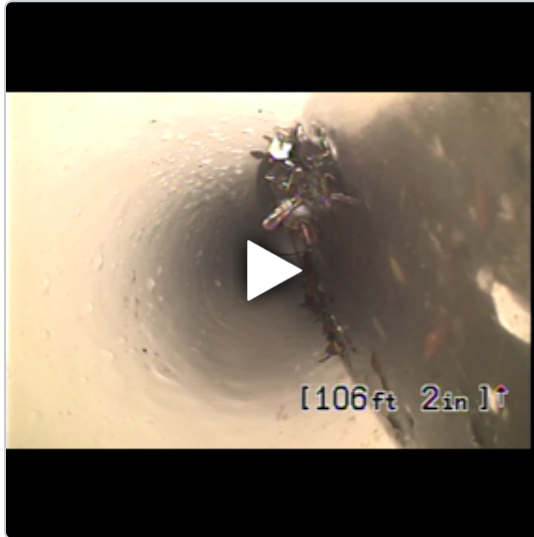
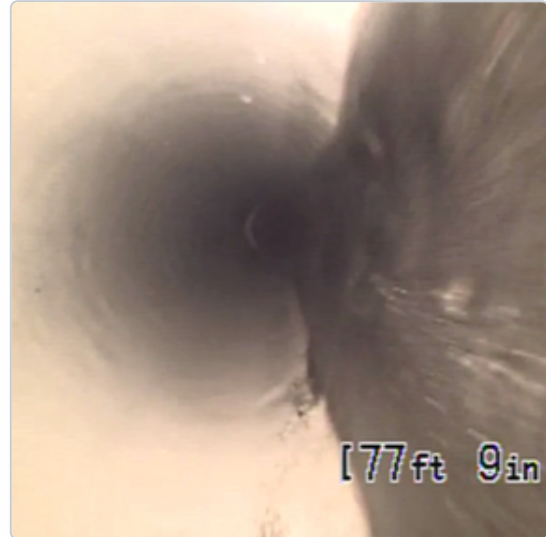
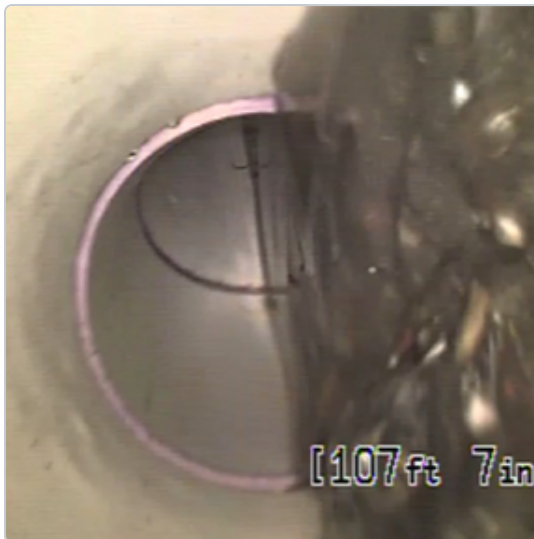
Unassigned**Post 25 - CO2 video (for reference)**

CO2 line: Invert elevation is 31.75" BFF. Jetted line. Filmed backwards from CO10.
Sag from 75' to 92' (0.5"+). Sag from 106' to 136' (1.5").

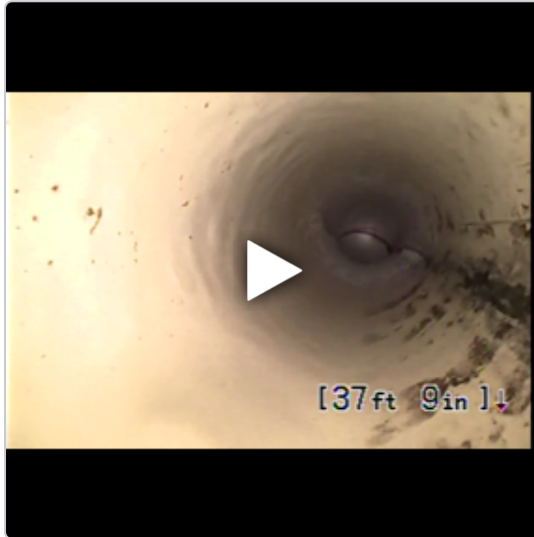
**Unassigned****Post 24 - CO3 video (for reference)**

CO3 line: Invert elevation is 17.25" BFF. Jetted line. Filmed backwards from CO5.
Line in good shape.

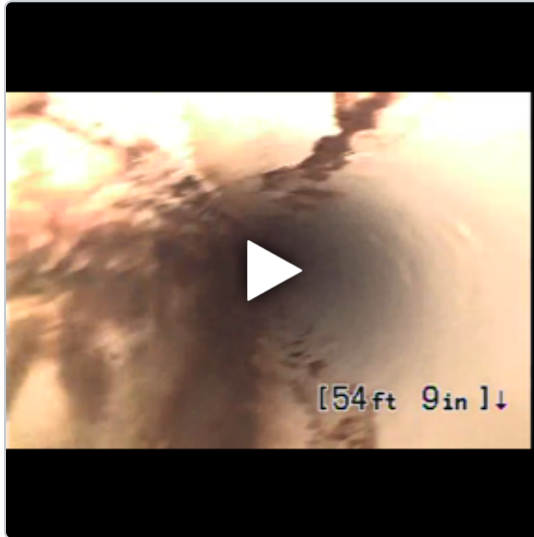
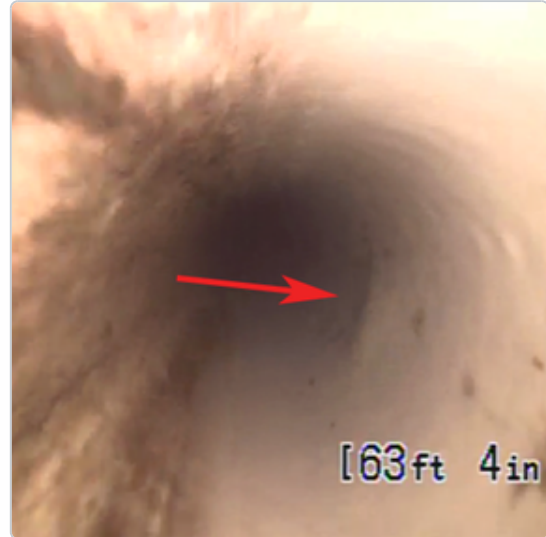
**Unassigned****Post 23 - CO4 video (for reference)**

CO4 line: Filmed backwards from CO6. 3" reducer in cleanout. Pipe anomaly (11:00 to 1:00 line position; less than 5% line loss) at 63'.

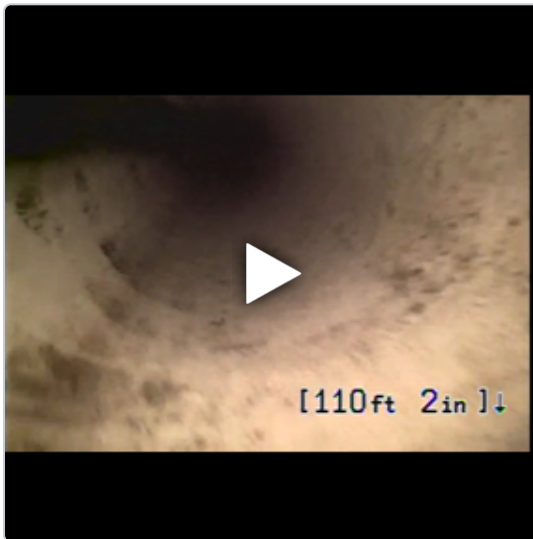
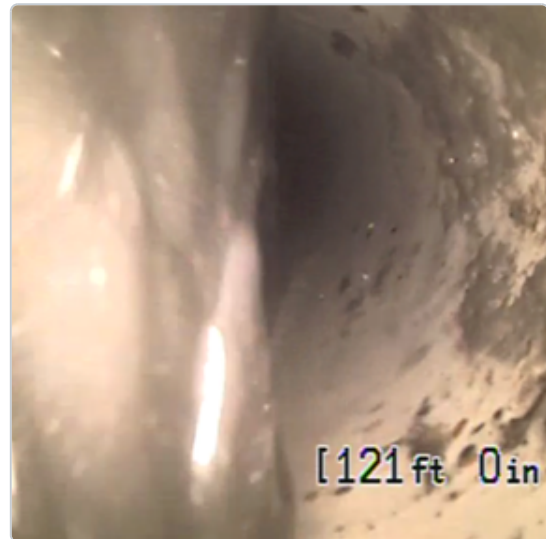
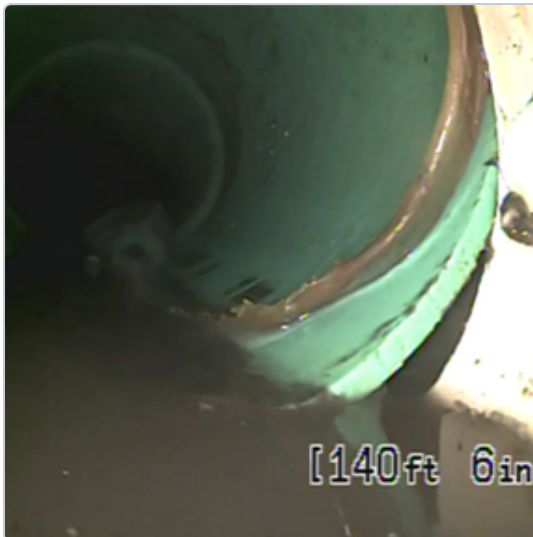
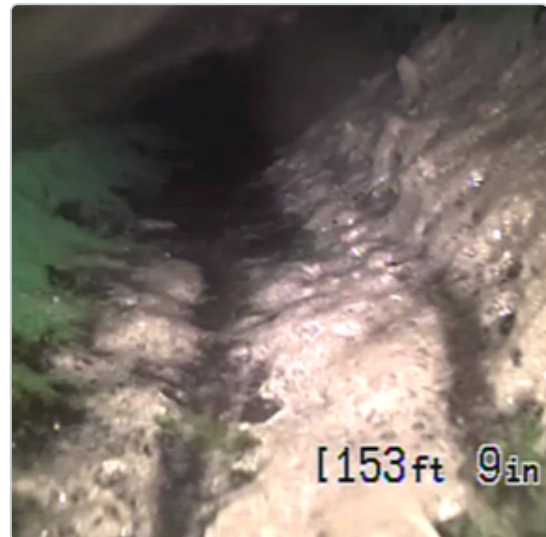
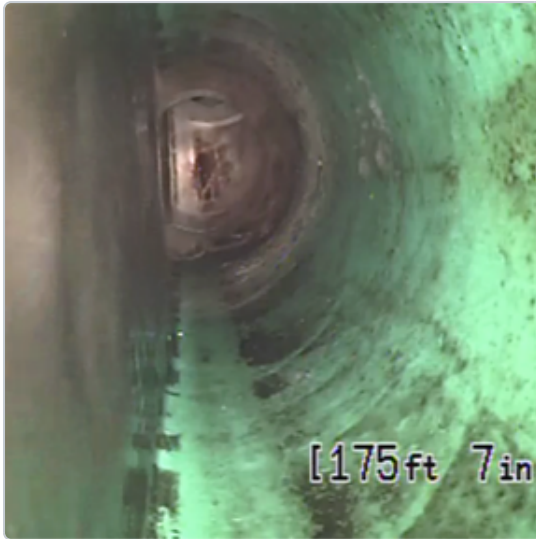
Unassigned**Post 22 - CO5 video (for reference)**

CO5 line: Invert elevation is 42.25" BFF. Jetted line. Filmed backwards from site line. Sag from 118' to 141' (2", with camera underwater most of issue). Joint offset at 141'. Sag from 153' to 163' (2", with camera underwater part of issue). Sag from 171' to 176' (1").

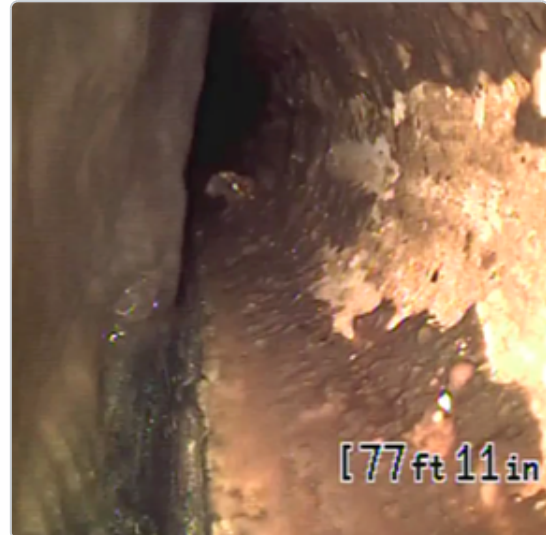
Unassigned**Post 21 - CO6 video (for reference)**

CO6 line: Invert elevation is 47" BFF. Filmed backwards from site line. Sag from 67' to 98' (2", with camera underwater part of issue). Sag from 117' to 124' (1.5"+). Sag from 134' to 141' (1").

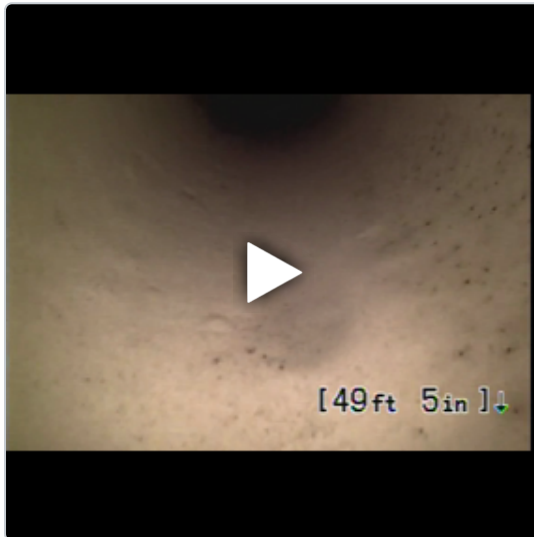
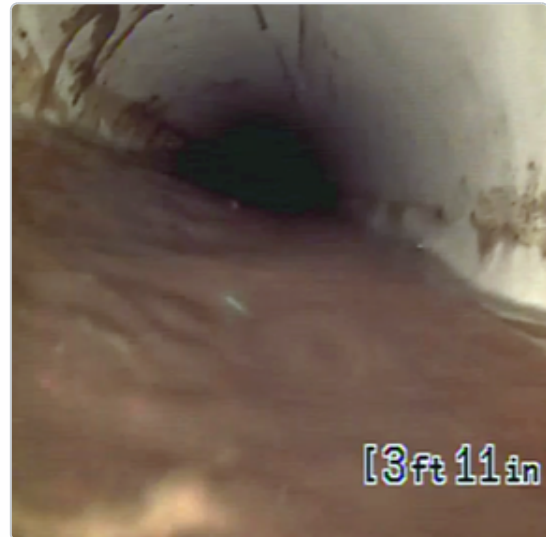
**Unassigned****Post 20 - CO7 video (for reference)**

CO7 line: Invert elevation is 37.25" BFF. Filmed backwards from CO5 line. Sag from cleanout to 34' (1.5"+).

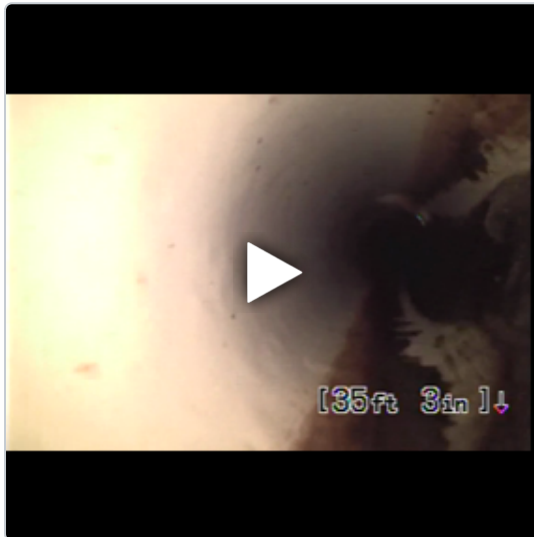
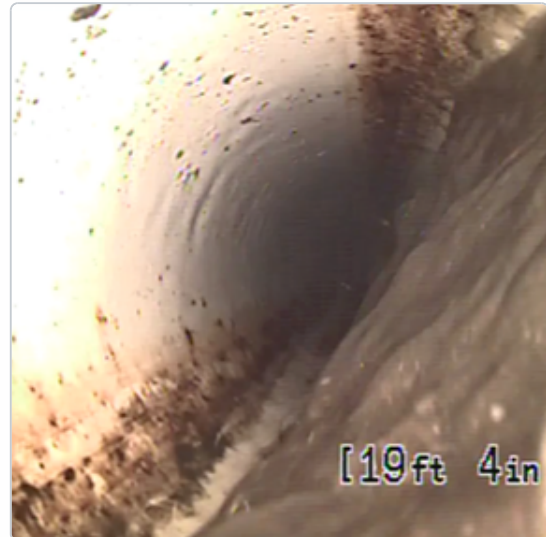
Unassigned**Post 19 - CO8 video (for reference)**

CO8 line: Invert elevation is 33" BFF. Filmed backwards from CO3 line. Sag from 13' to 24' (1.5"+).

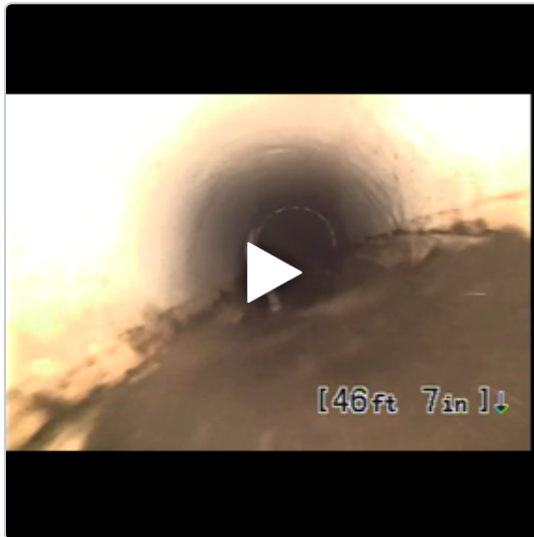
**Unassigned****Post 18 - CO9 video (for reference)**

CO9 line: Invert elevation is 36.75" BFF. Jetted line. Filmed backwards from CO1 line. Line in good shape.

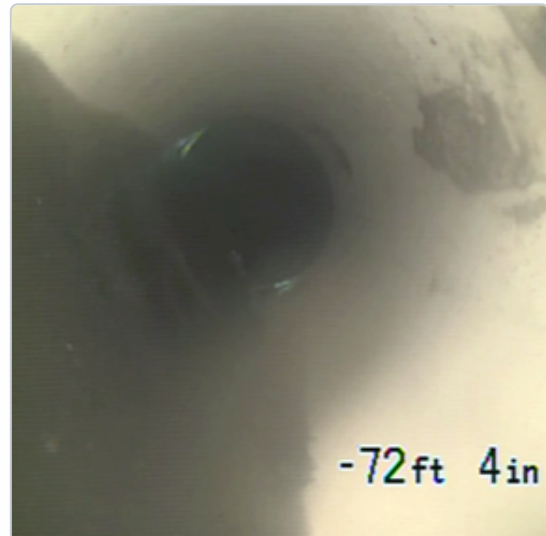
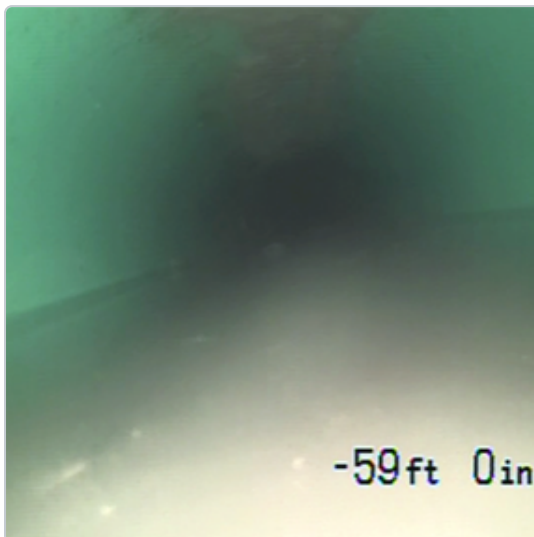
Unassigned**Post 17 - CO10 video (for reference)**

CO10 line: Invert elevation is 50" BFF. Jetted line. Filmed backwards from grease trap. Joint offset at 110' with associated sag from 106' to 110' (1"). Sag from 120' to 125' (1.5"+).

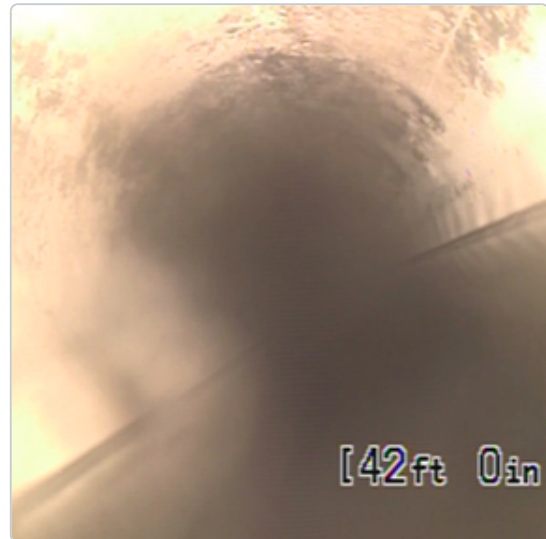
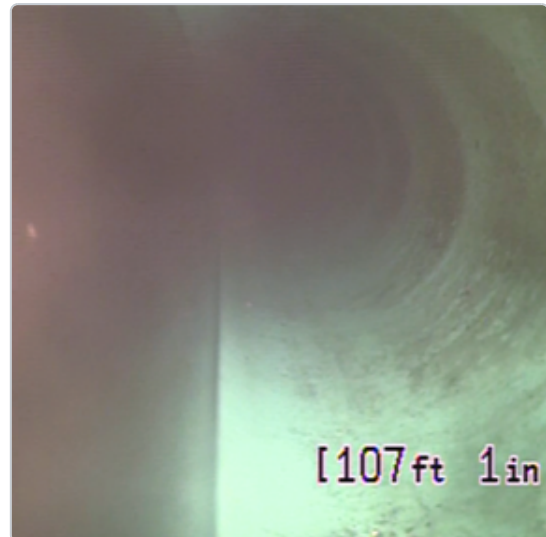
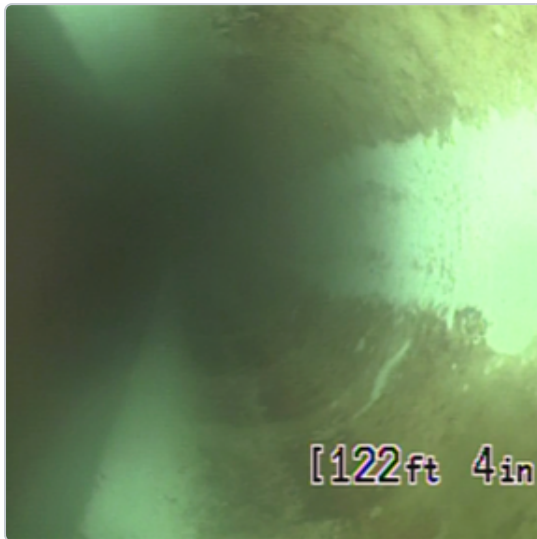
Unassigned**Post 16 - CO11 video (for reference)**

CO11 line: Invert elevation is 48.75" BFF. Jetted line. Filmed backwards from site line. Sag from 32' to 50' (2", with camera underwater part of issue). Joint offset at 107' with associated sag from 106' to 112' (1"+). Sag from 119' to 124' (0.5"+). Sag from 136' to 143' (1").

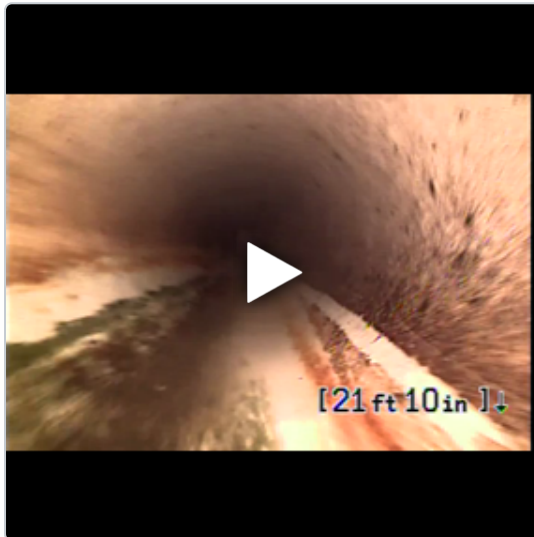
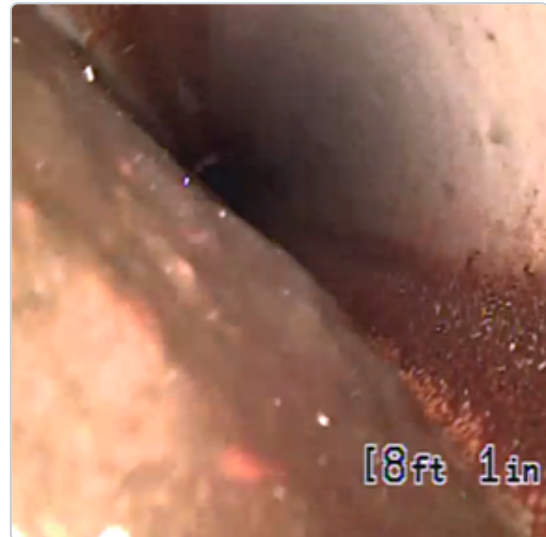
Unassigned**Post 15 - CO12 video (for reference)**

CO12 line: Invert elevation is 37.75" BFF. Filmed backwards from CO11 line. Sag from cleanout to 19' (1").

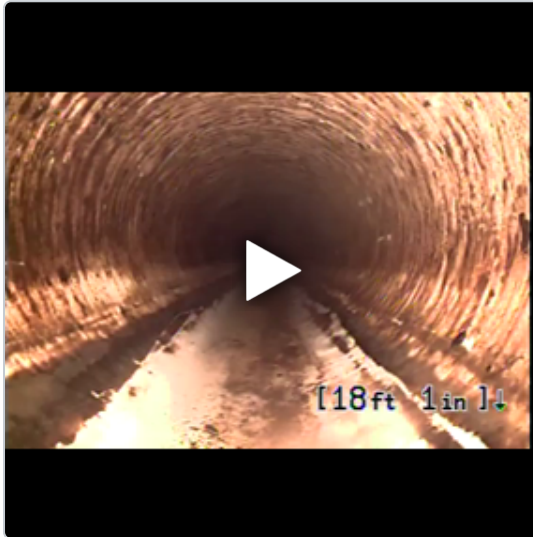
Unassigned**Post 1 - CO13 video (for reference)**

CO13 line: Invert elevation is 45.25" BFF. Filmed backwards from CO11 line. Line in good shape.
