# Visual Roof Inspection Report

Food Lion Store #:  
2250

1555 E. Union Street  
Morganton  
NC  
28655

07/10/2019

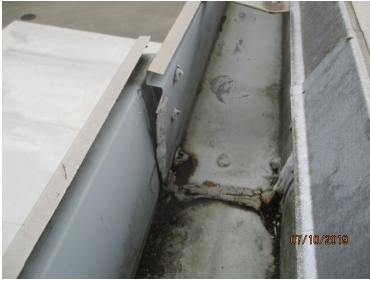
Deficiency Item #:	Deficiency Detail:	Correction:	Code:	Photo:	Quantity:	Unit:	Total:
1	A-1: Unsecured gutter seam with deteriorated sealant	Secure and Seal	C

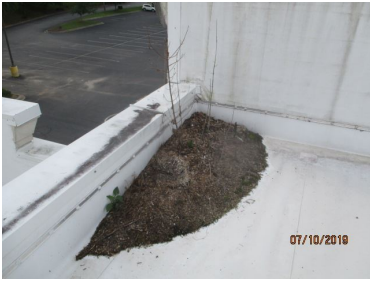
2	Item	\$750.00
2	A-2: Debris on roof surface	Remove	C

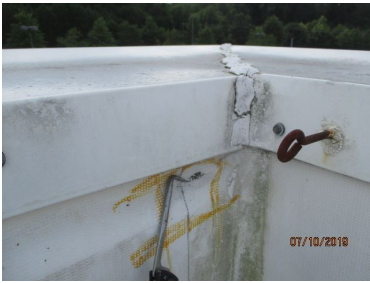
50	SQ FT	\$350.00
3	A-3: Tear in parapet wall flashing	Patch & Seal	E

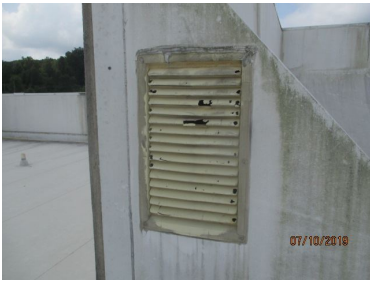
3	Item	\$600.00
4	A-4: Deteriorated wall vent	Replace	C

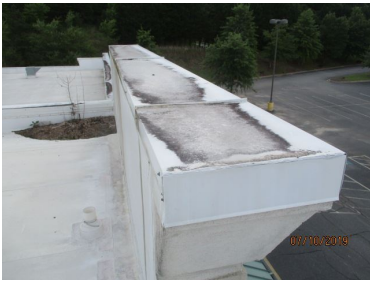
1	Item	\$400.00
5	A-5: Evidence of ponding on coping.	Monitor	3

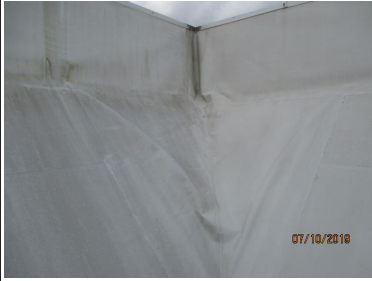
Deficiency Item #:	Deficiency Detail:	Correction:	Code:	Photo:	Quantity:	Unit:	Total:
6	A-6: Loose wall flashing	Monitor	3

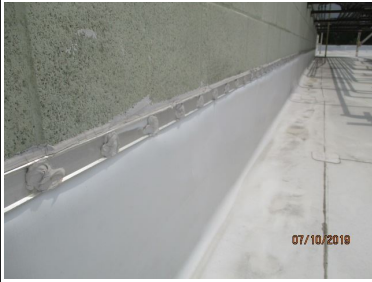
100	SQ FT	\$0.00
7	A-7: Deteriorated sealant above termination bar.	Monitor	3

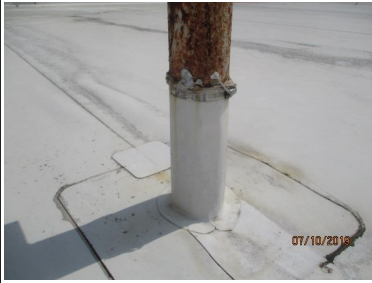
80	LF	\$0.00
8	A-8: Deteriorated sealant at pipe penetrations	Monitor	3

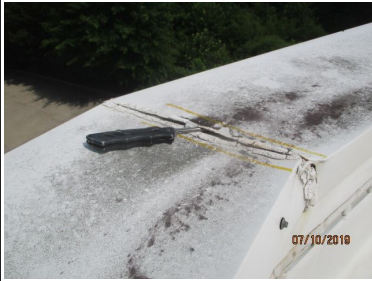
12	Item	\$0.00
9	B-1: Deteriorated sealant at coping seam.	Reseal	C

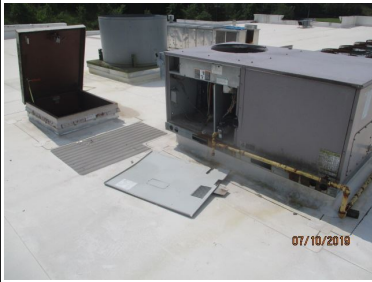
1	Item	\$350.00
10	B-2: Equipment panel on roof surface	Remove or Secure	E

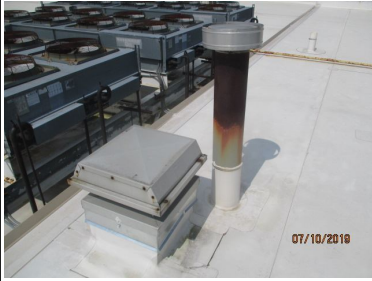
Deficiency Item #:	Deficiency Detail:	Correction:	Code:	Photo:	Quantity:	Unit:	Total:
11	B-3: Rusting at hot stack	Apply rust inhibitor	3

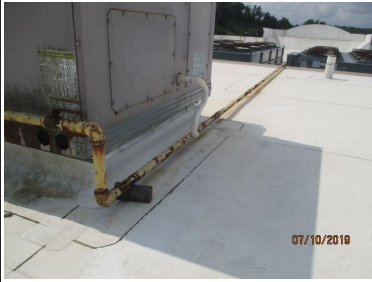
1	Item	\$350.00
12	B-4: Missing wood blocking supports under gas line	Install wood blocking	2

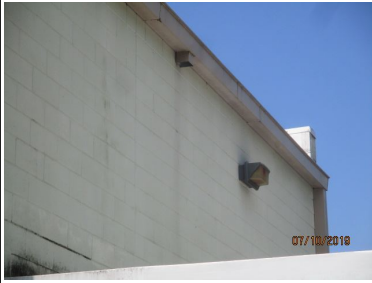
5	Item	\$350.00
13	Unsecured downspout above cooler	Secure	C
