Visual Roof Inspection Report

Food Lion Store #:
1653

1565 Hyde Park Rd
Essex
MD
21221

04/04/2019

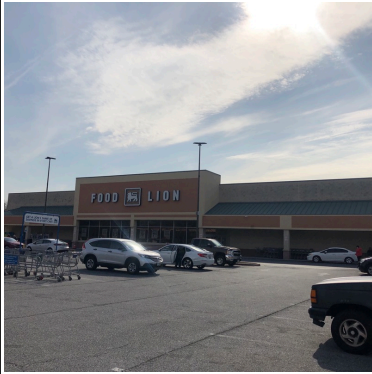
Deficiency Item #:	Deficiency Detail:	Correction:	Code:	Photo:	Quantity:	Unit:	Total:
Store Front	Store Front

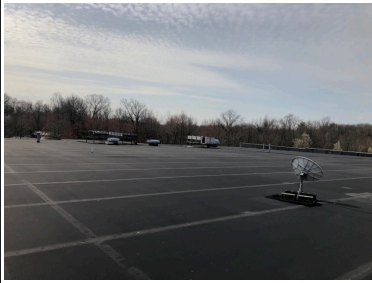
Item	\$0.00
Overview A	Overview of Section A.

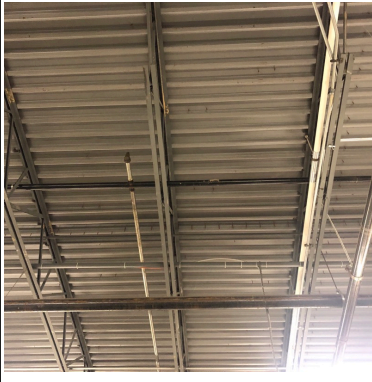
Item	\$0.00
Underside of Deck A	Deck

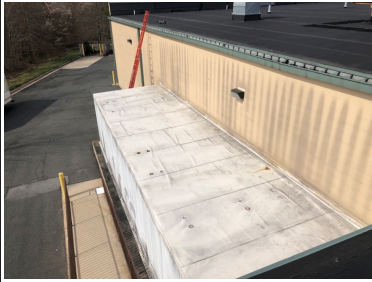
Item	\$0.00
Overview B	Overview of Section B.

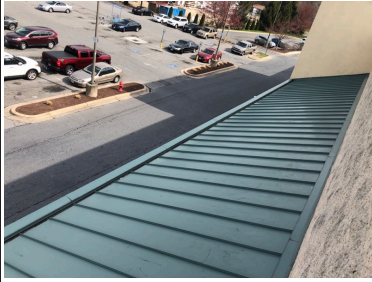
Deficiency Item #:	Deficiency Detail:	Correction:	Code:	Photo:	Quantity:	Unit:	Total:
Overview C	Overview of Section C.

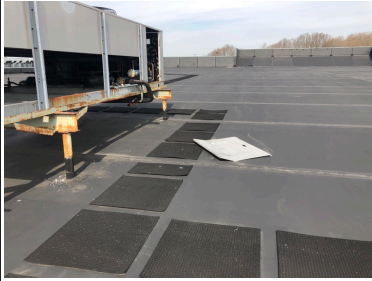
Item	\$0.00
Section A: 1	Equipment door on roof.	Reattach or remove.	E

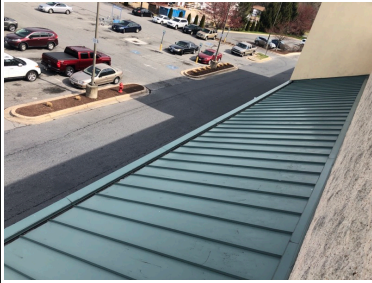
Roof sections A, B, and C are in fair condition with no active leaks. The roofs are likely original construction making them 19 years of age. The metal roofs to the front have a gutter that are clogged with leaves. RSI estimates another five years of service life remains with proper maintenance. \$3,500.00 is the recommended annual budget to address maintenance and remedial repairs.

1	Item	\$200.00
Section C: 1	Clean gutters.	Clean leaves from front gutters.	E

132	LF	\$396.00
