**FOOD LION #1653 REVISED DRAIN SURVEY PER ENGINEERING REVIEW;**  
**10/7/19** 1/6/2019 - 10/14/2019

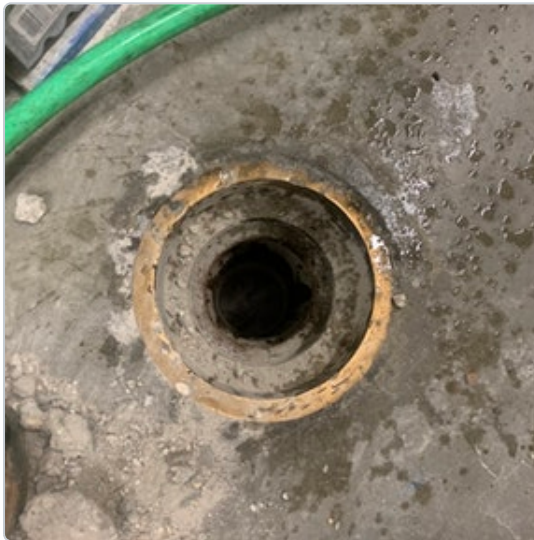
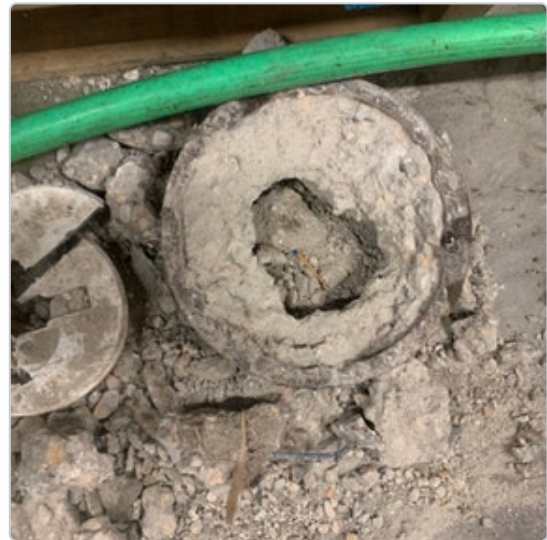
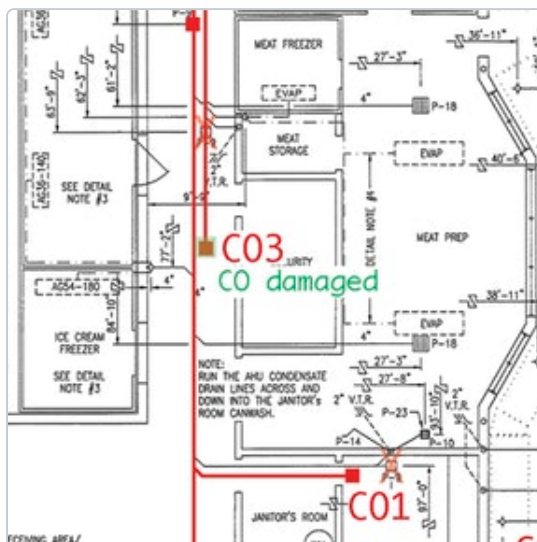
### Post 3 - CO3 - Cleanout fixture's weight was broken.

Upon arrival, cleanout was filled with concrete.

Replace the entire cleanout fixture.

Per email from Food Lion Engineering on 10/7/19, item is to be included in remodel documents.

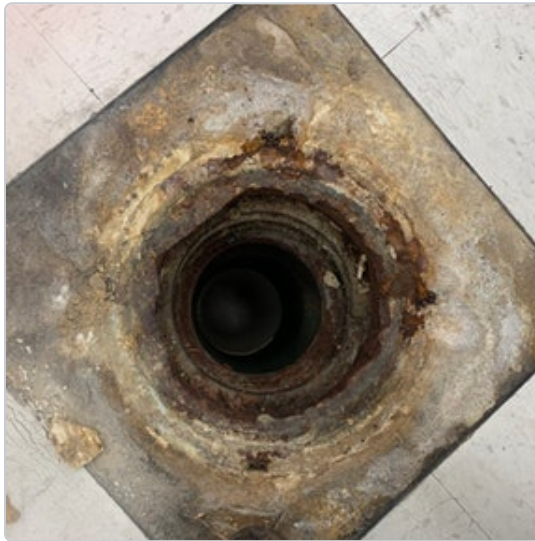
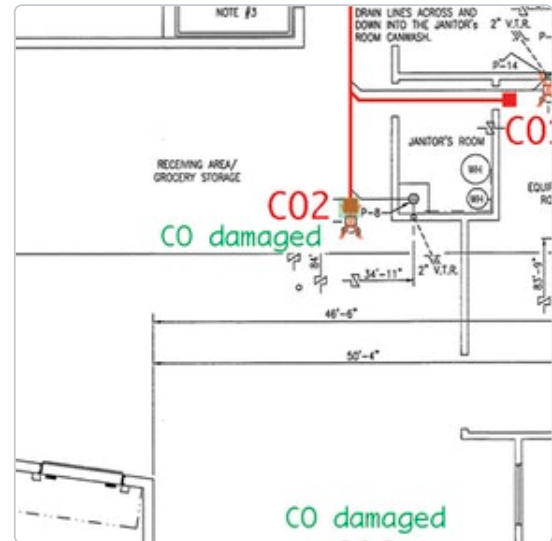
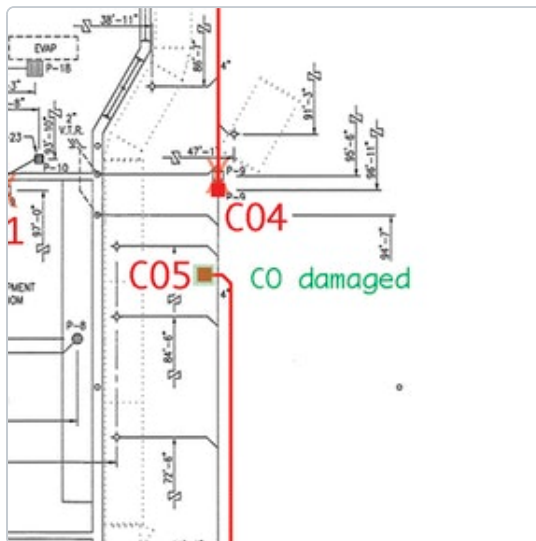
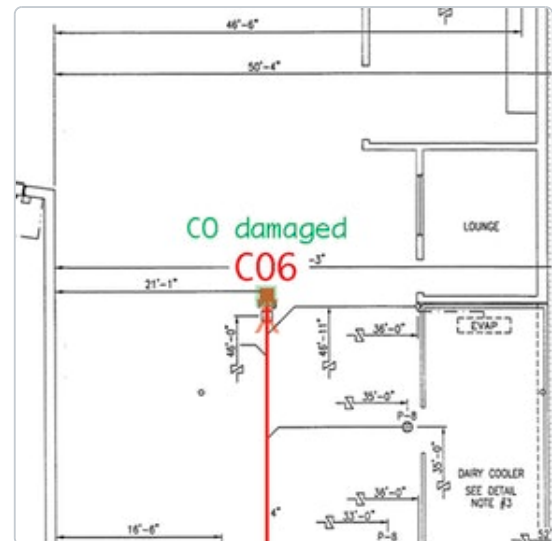
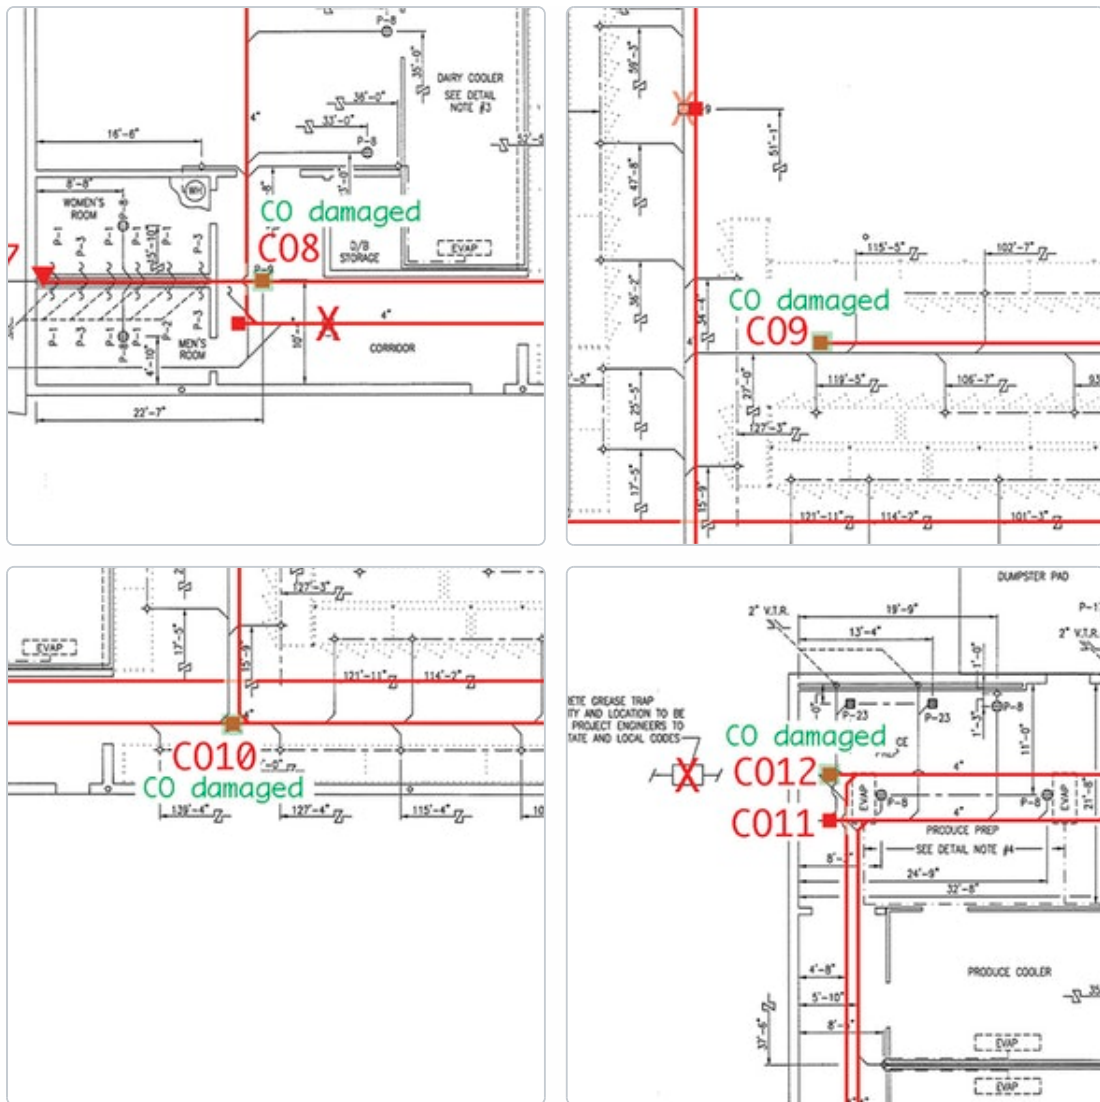
**Post 15 - Cleanouts CO2, CO5, CO6, CO8, CO9, CO10 and CO12 weights were broken prior to arrival**

Cleanouts should be replaced.

- Per email from Food Lion Engineering on 10/7/19, item is to be included in remodel documents.

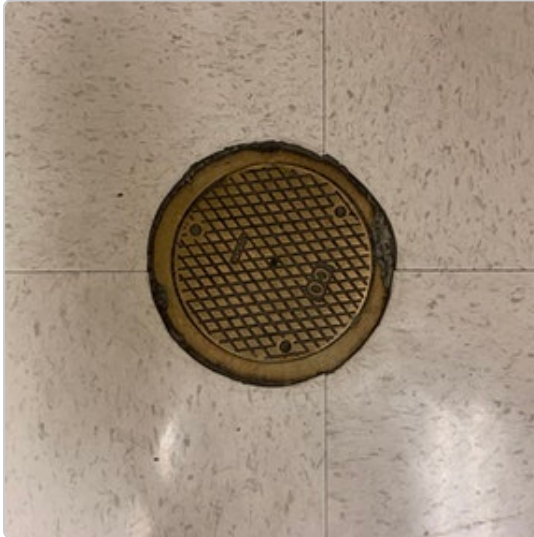
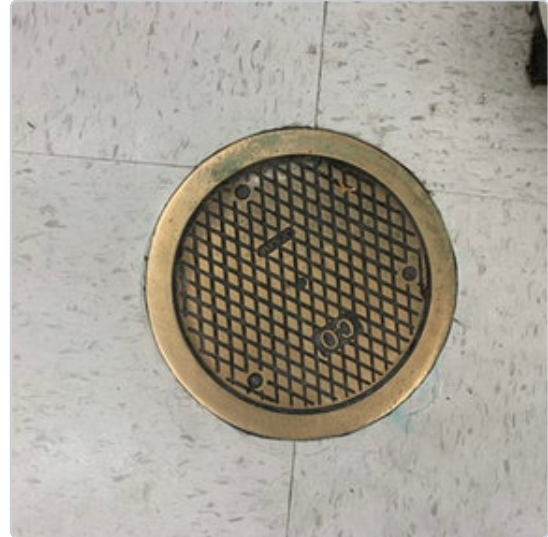
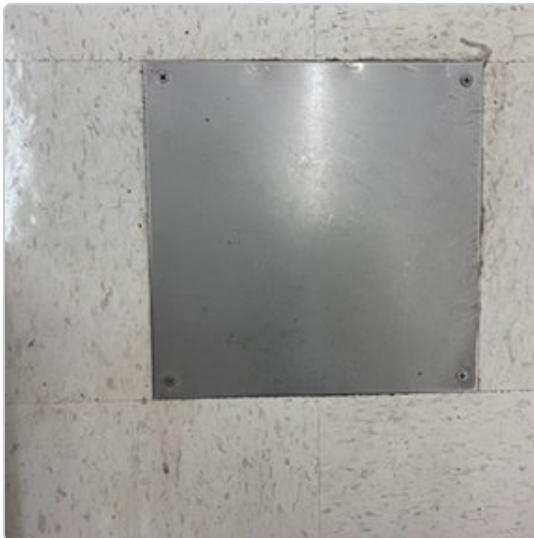
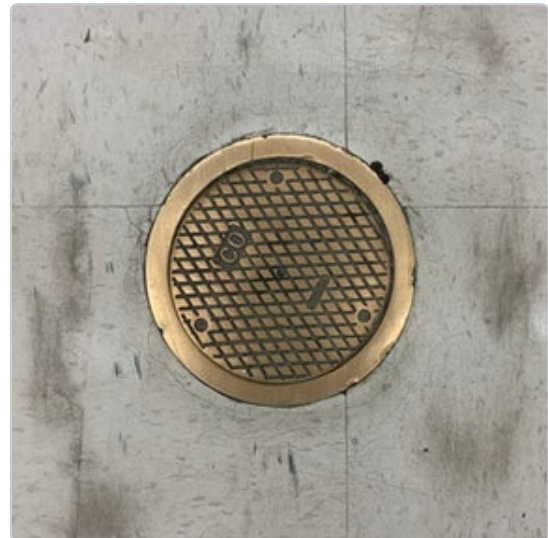
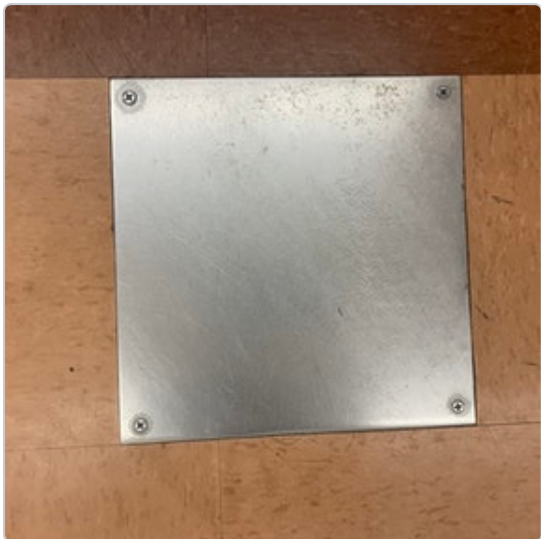
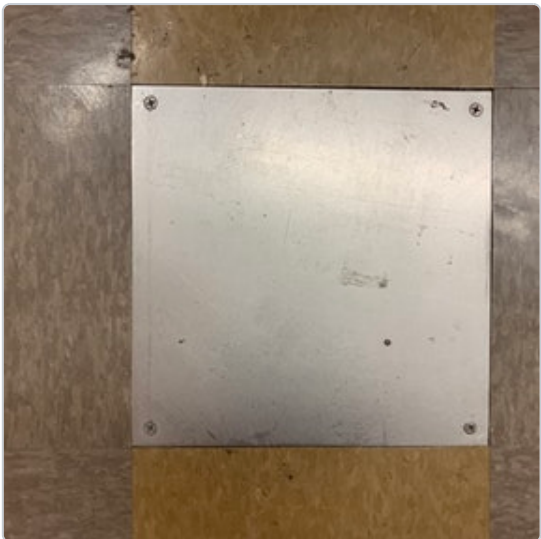
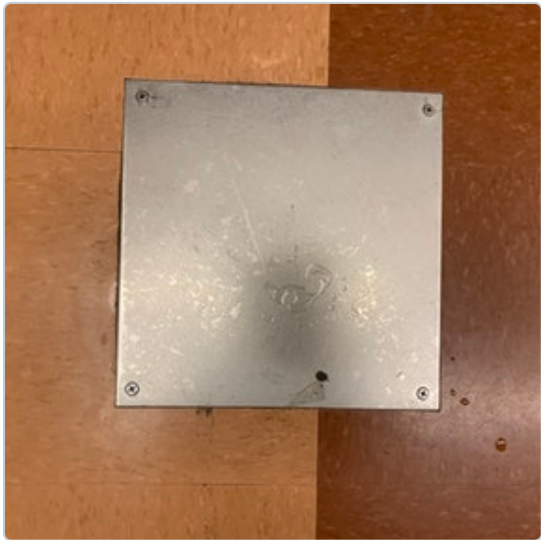
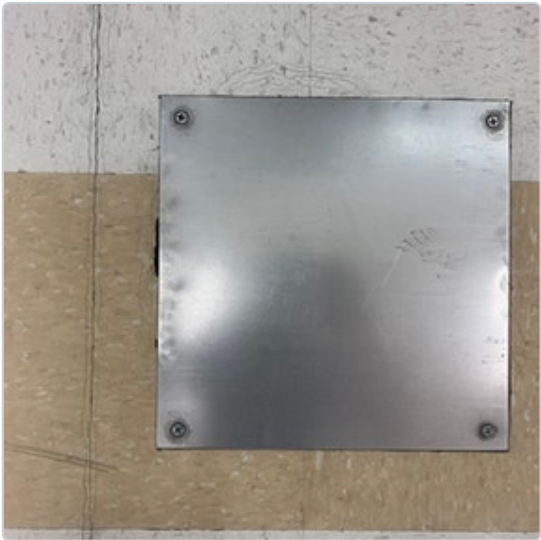
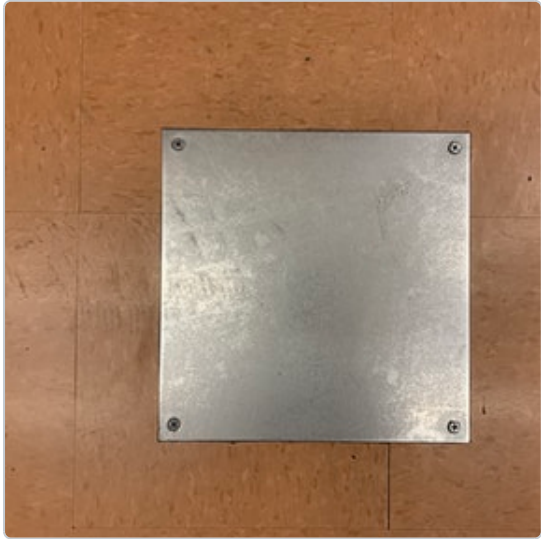
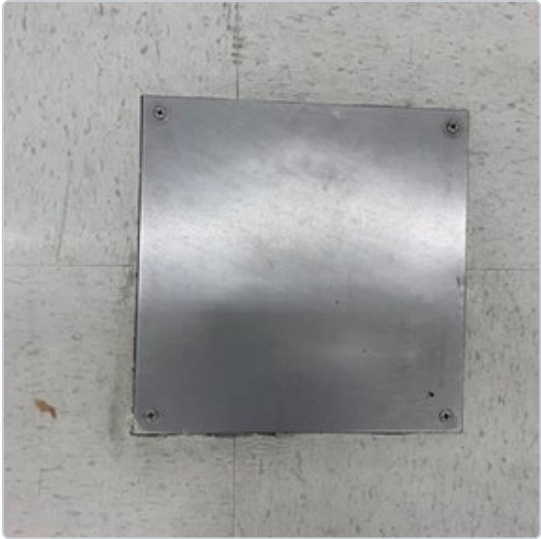
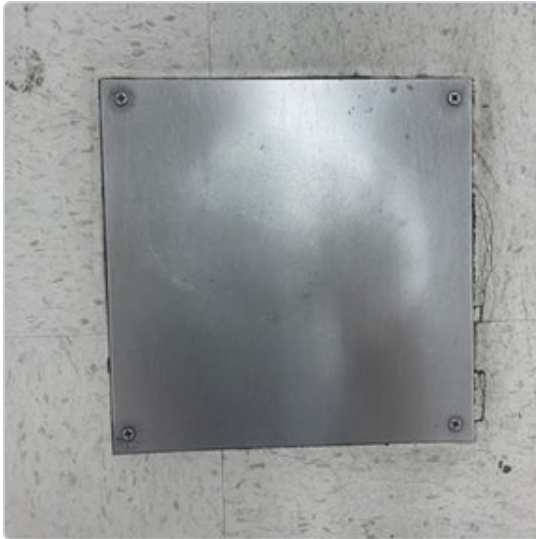
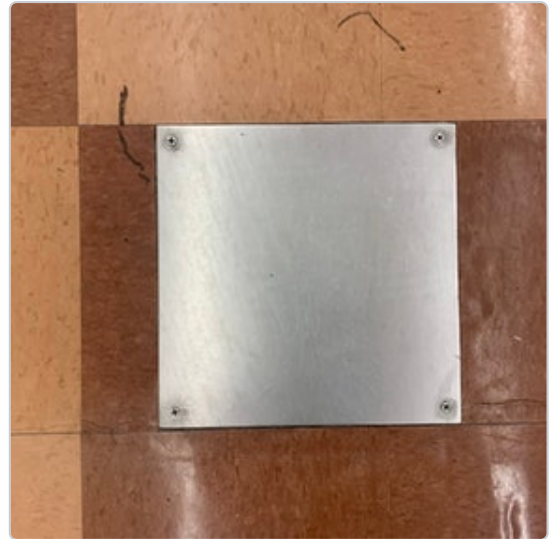
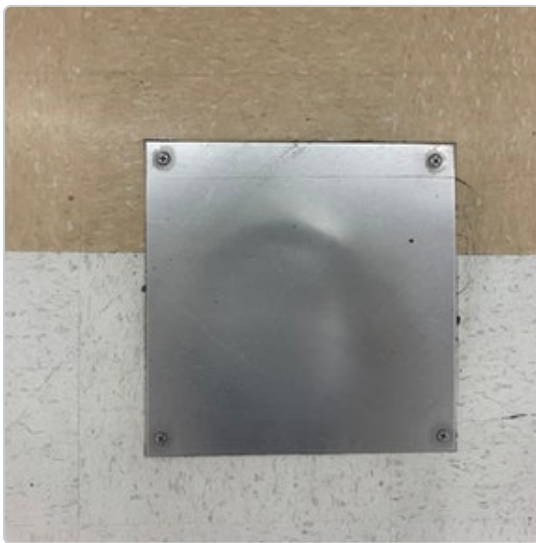
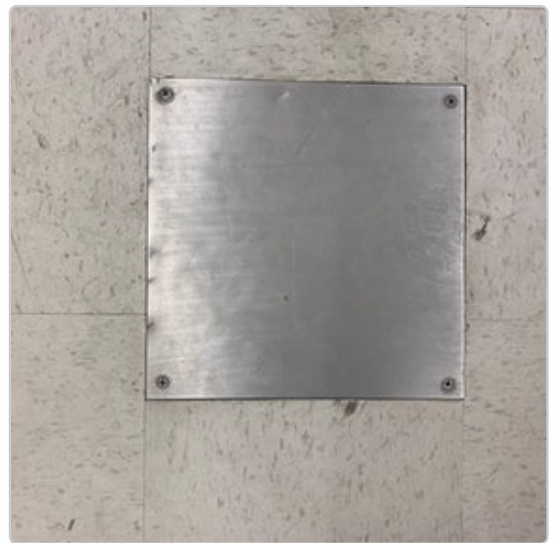
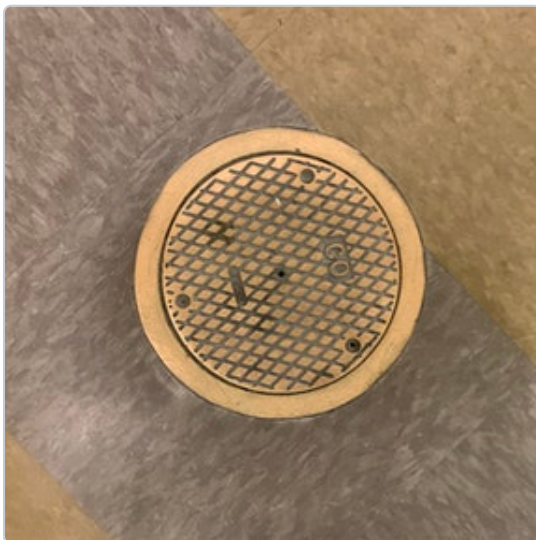
The sales floor cleanouts typically have surrounding tile damage / unlevel / should be cleared of excess wax and debris. Ensure all are level with finish floor upon closeout of remodel. Consider replacing fixtures.

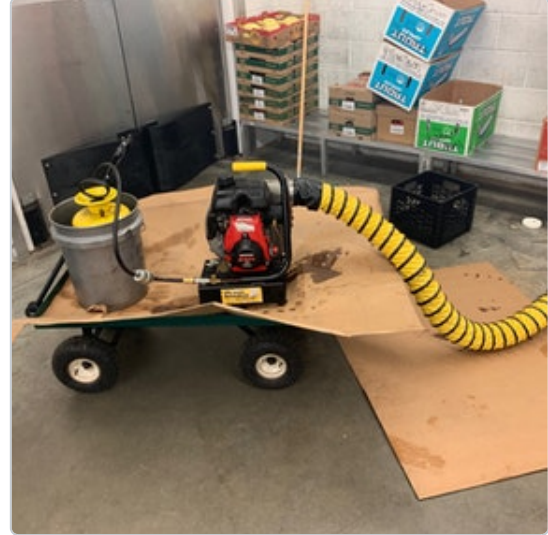
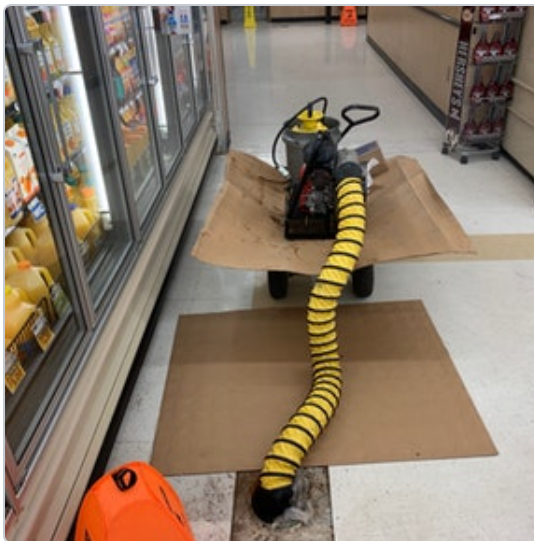
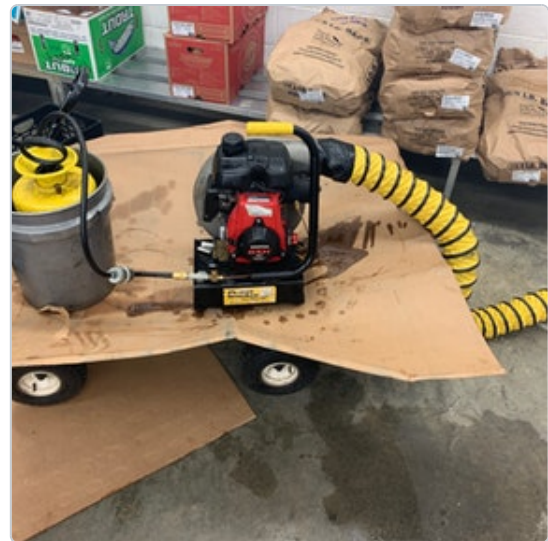
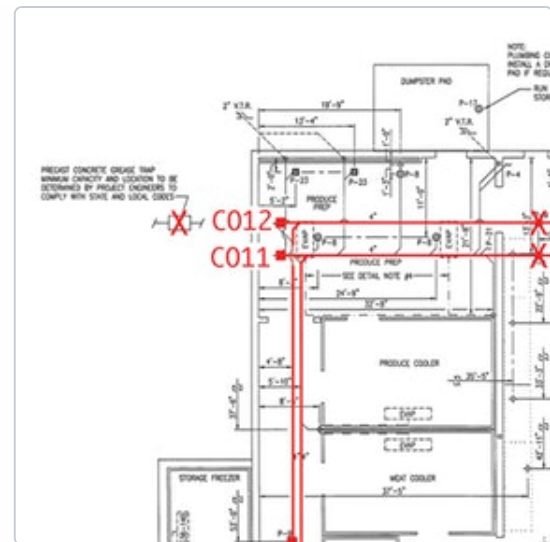
Unassigned**Post 6 - Smoke test performed from cleanouts CO8, CO10, CO11 and CO12-05/09/2019**

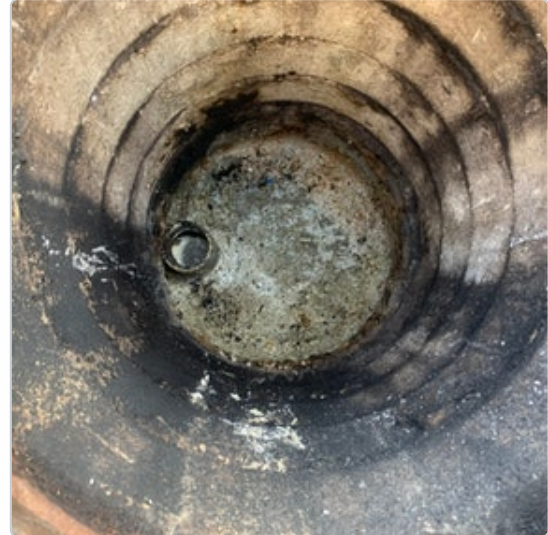
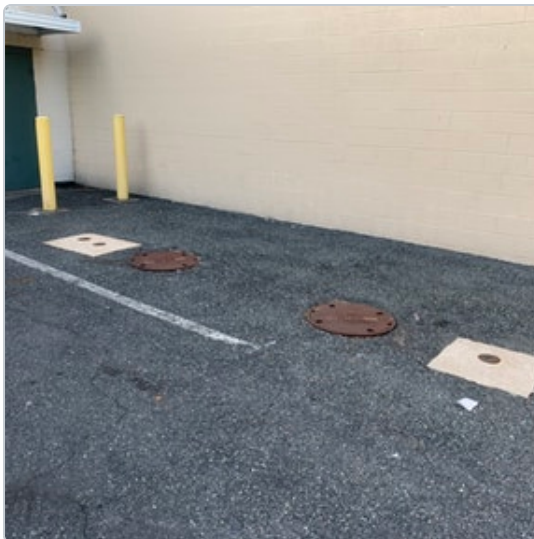
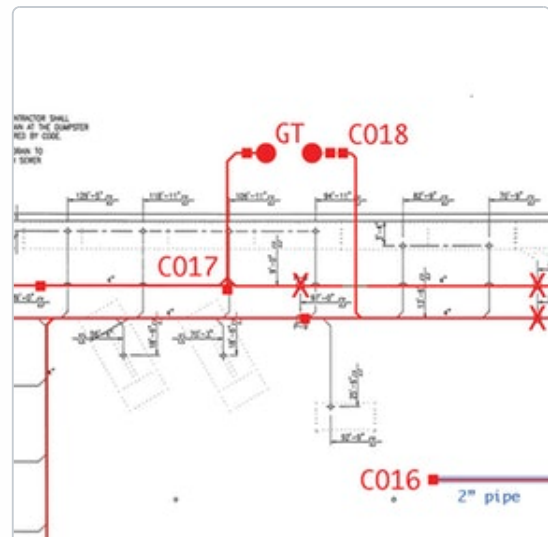
**Post 9 - Grease trap - Appears to be functioning normally with inlet 1/2" above outlet.**

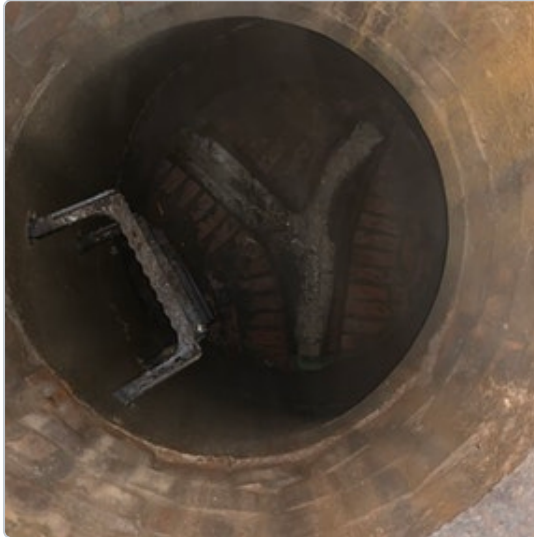
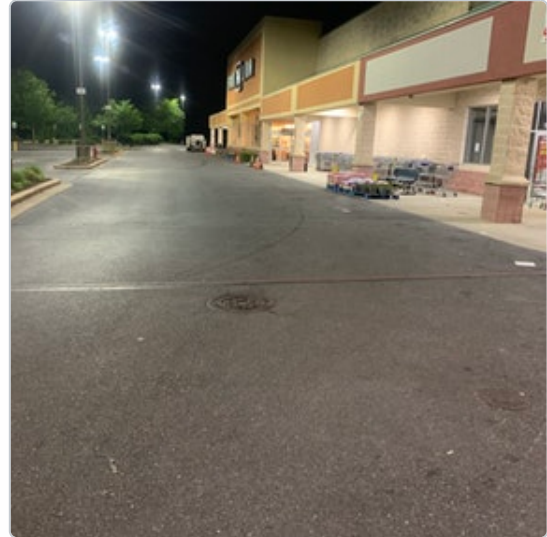
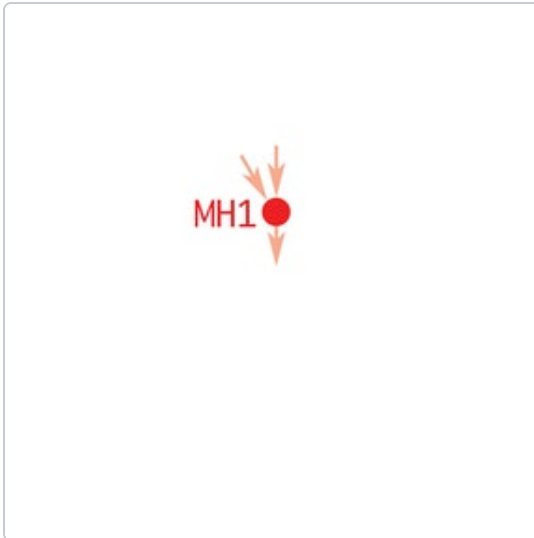
Unassigned**Post 8 - Manhole MH1**

Manhole is flowing/operating normally.

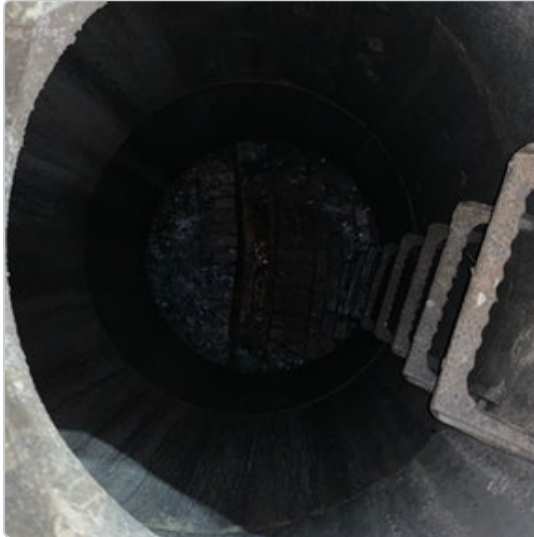
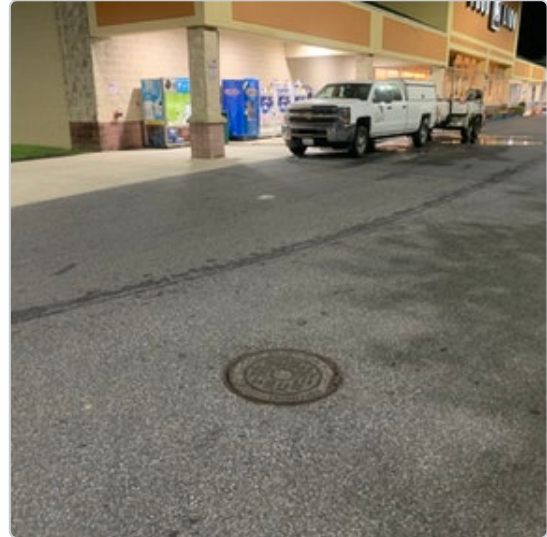
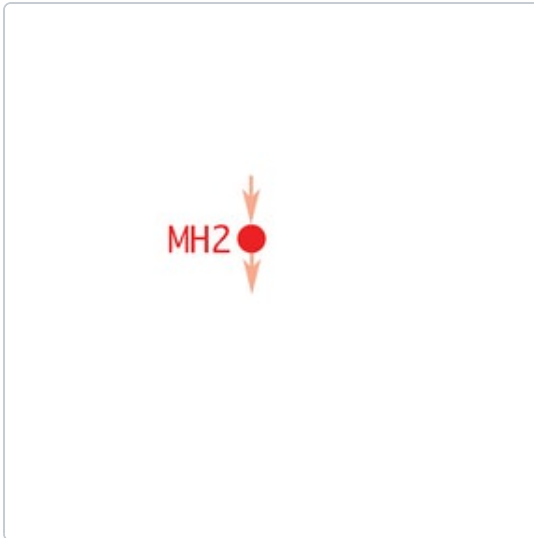
Unassigned**Post 14 - Manhole MH2**

Manhole is flowing/operating normally.

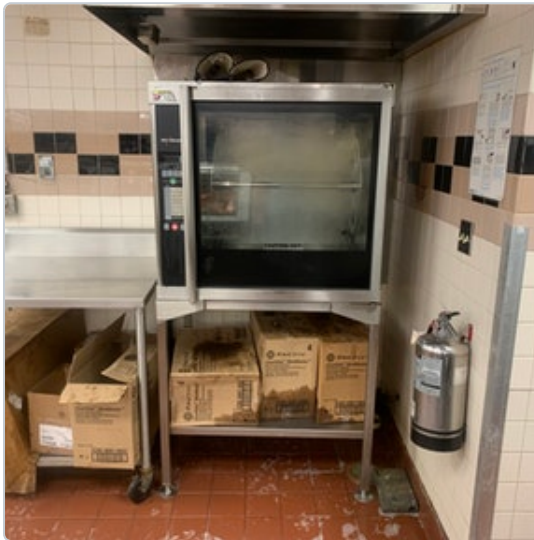
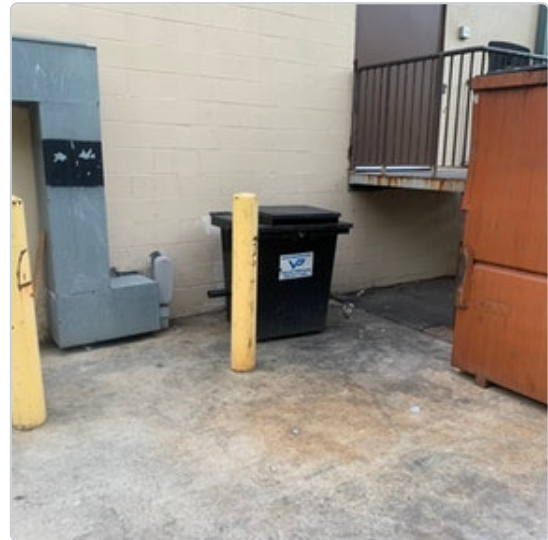
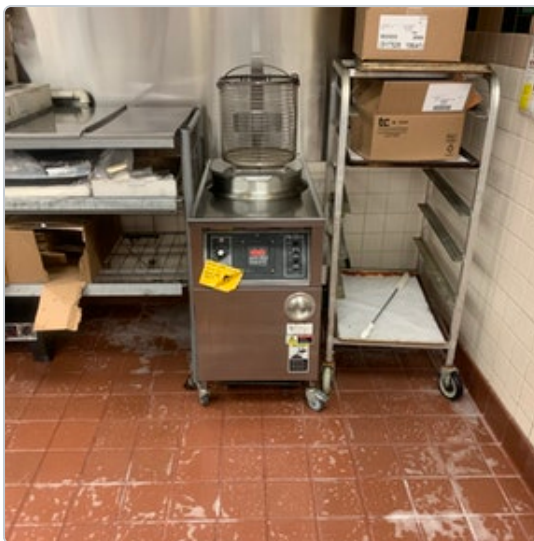
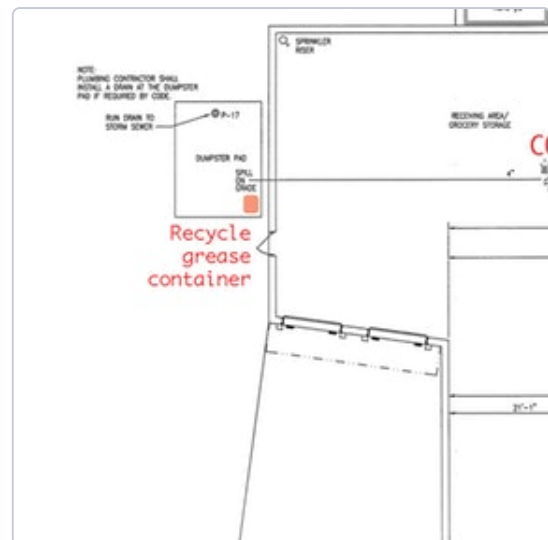
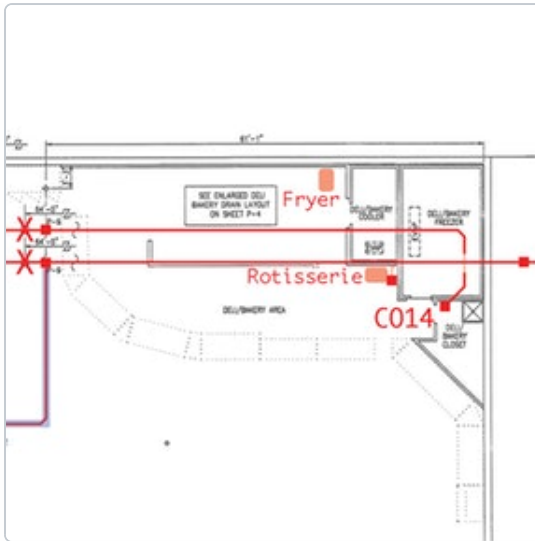
Recycle grease container verified to be onsite.

Rotisserie and fryer appear to be manually emptied.

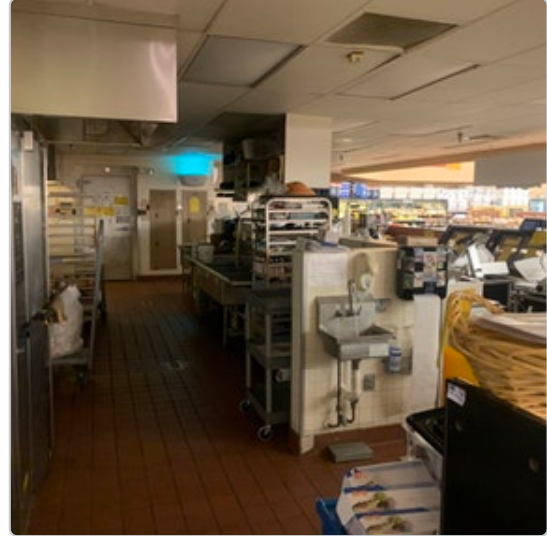
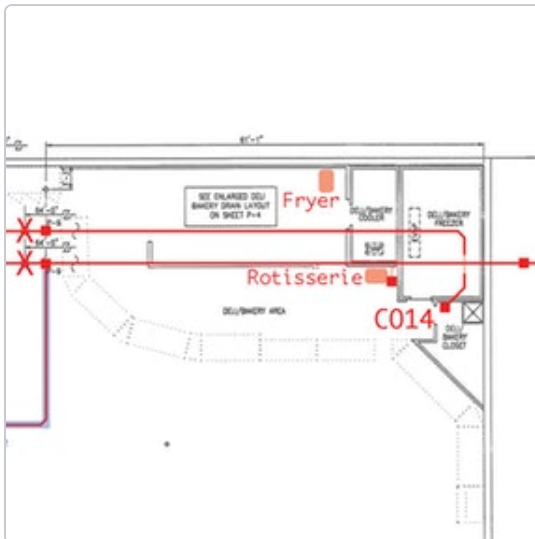
The deli prep area floor drains, prep sinks, and mop sink were confirmed to go to CO14 line.

All grease prep area sinks and drains were confirmed to go to the existing grease trap.

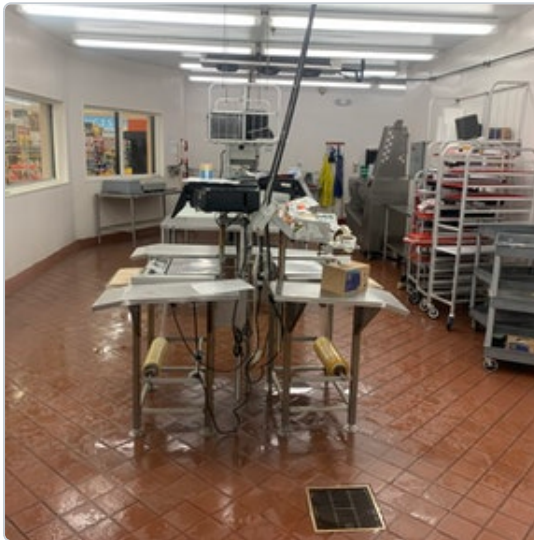
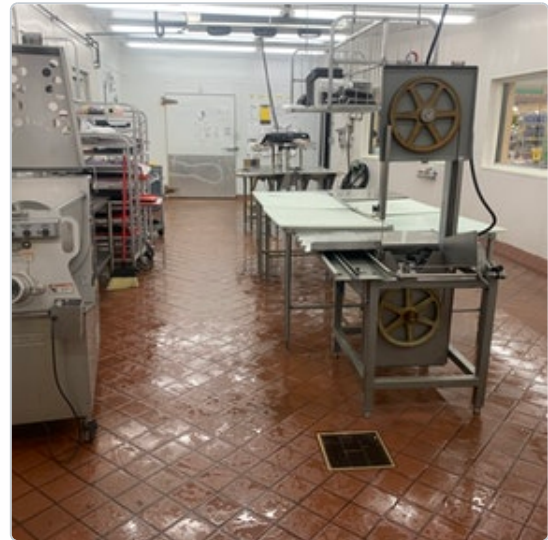
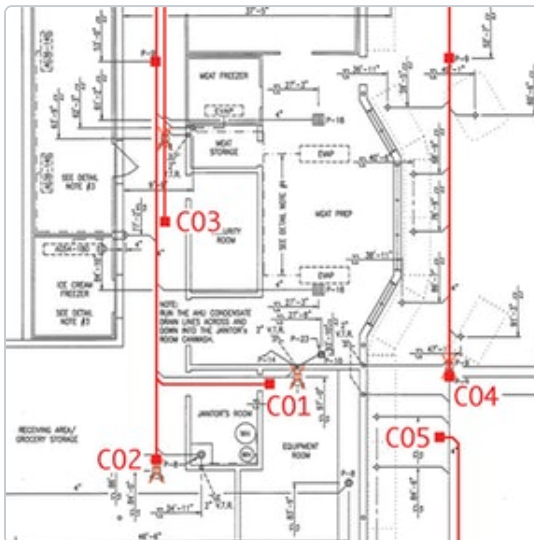
The meat prep area three-compartment sink was confirmed to go to CO1 line.

The meat prep floor drains and grocery storage mop sink were confirmed to go to CO2 line.

All grease prep area sinks and drains were confirmed to go to the existing grease trap.

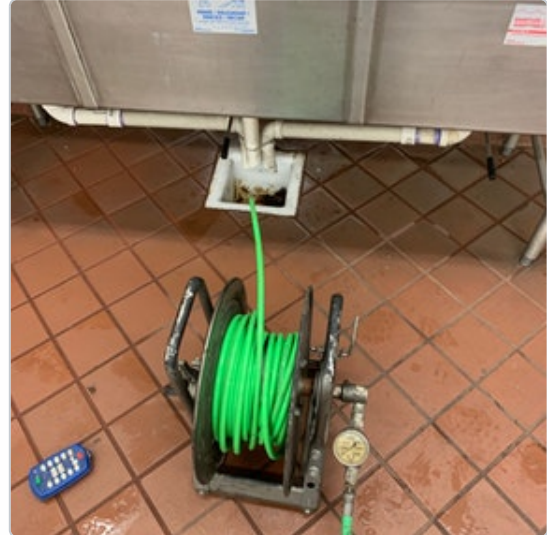
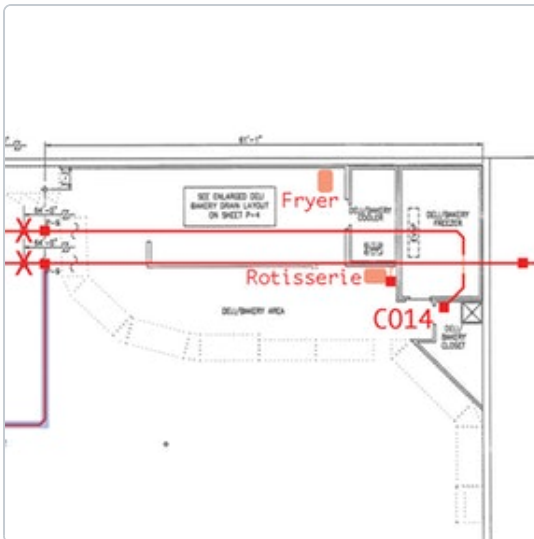
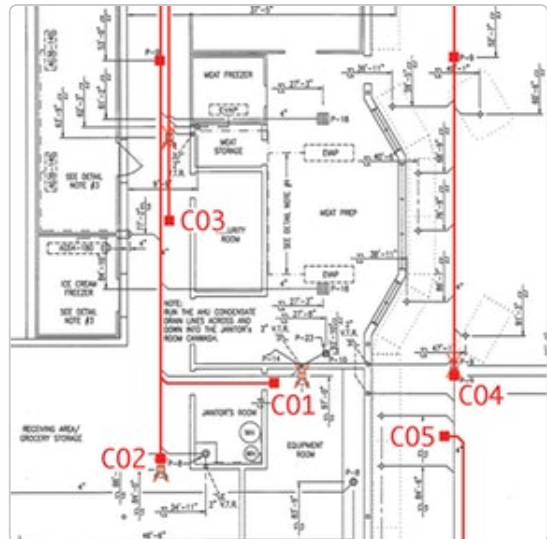
**Post 10 - All individual prep area grease waste drains were cleaned with mini jet kit.**

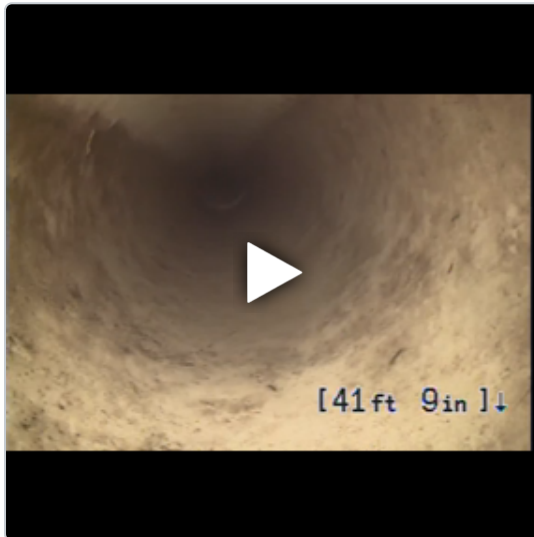
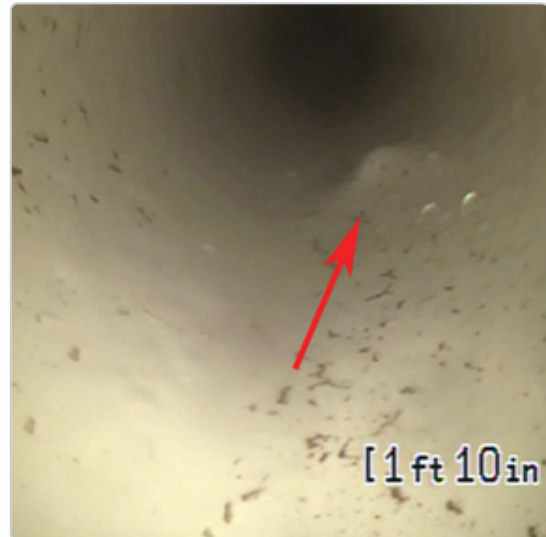
CO4 line: Invert elevation is 19.5" BFF. Filmed backwards from CO11 line. Pipe anomaly (10:00 line position; less than 5% line loss) at 1'.

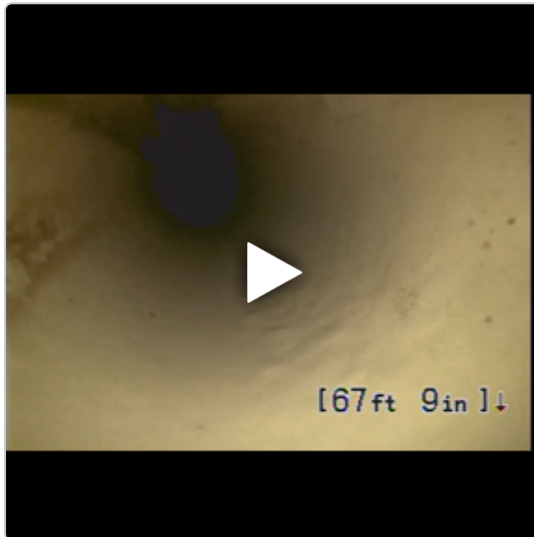
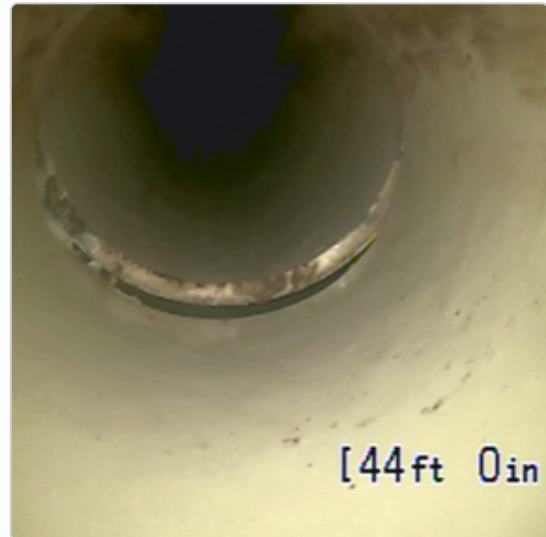
CO8 line: Invert elevation is 41.25" BFF. Filmed backwards from CO13. Joint offset at 44'.

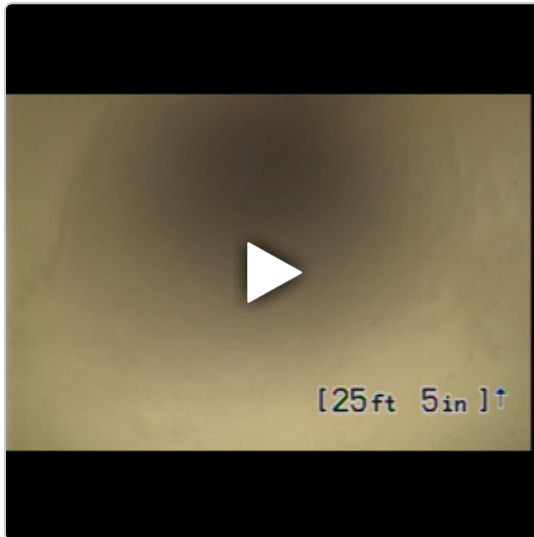
CO12 line: Invert elevation is 28.75" BFF. Jetted line. Filmed backwards from CO17 line. Pipe anomaly (2:00 to 3:00 line position; less than 5% line loss) at 25'.

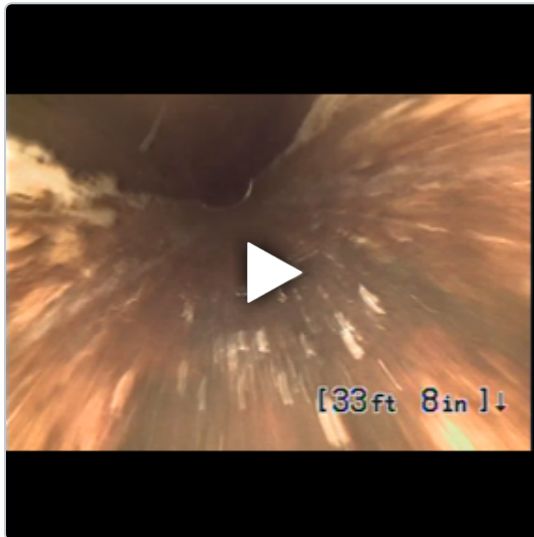
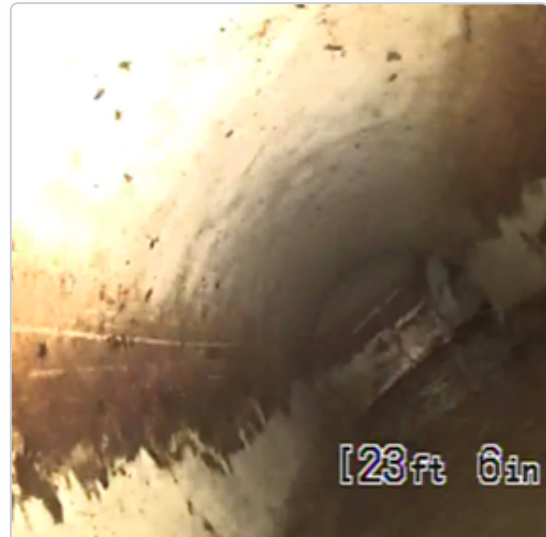
CO13 line: Invert elevation is 65.25" BFF. Filmed backwards from site line. Sag from 20' to 25' (0.5"+).

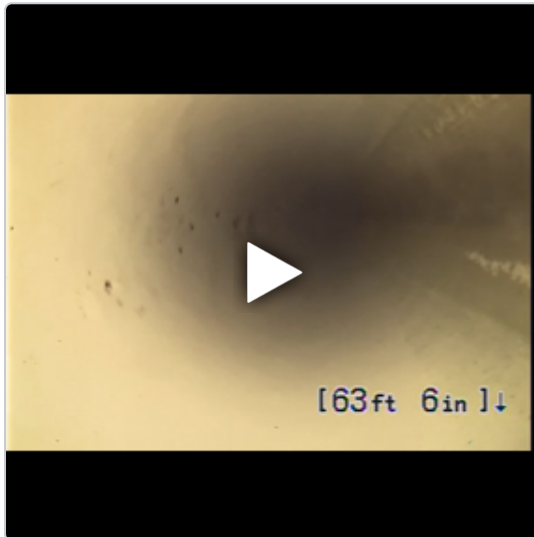
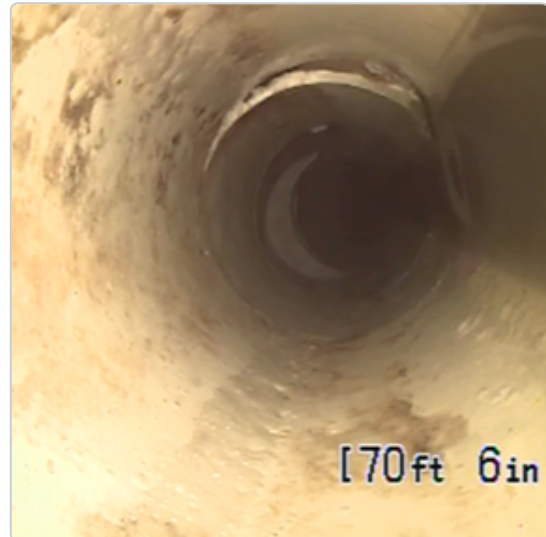
CO14 line: Invert elevation is 14.75" BFF. Jetted line. Filmed backwards from CO17 line. Joint offset at 71'.

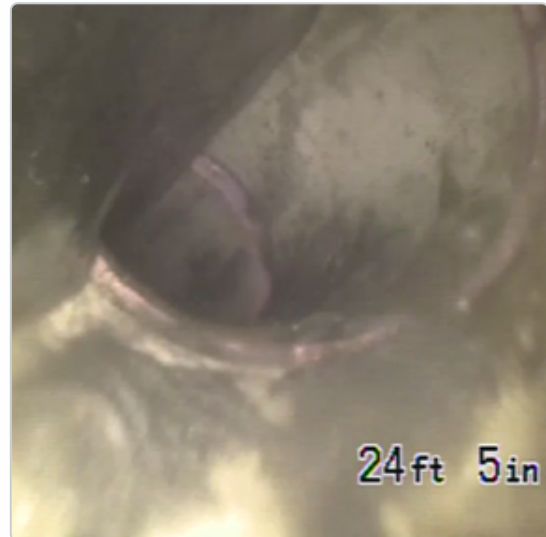
CO17 line: Invert elevation is 48.75" BFF. Filmed backwards from grease trap. Sag from 21' to just before grease trap inlet at 27' (1.5").

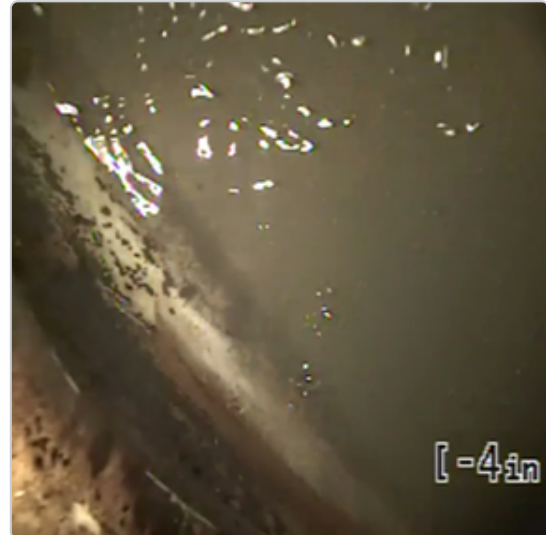
CO18 line: Filmed backwards from CO11 line. Sag from cleanout to 7' (2"+, with camera underwater most of issue). Pipe anomaly (10:00 to 12:00 line position; 5% line loss) at 7'.
