Visual Roof Inspection Report

Food Lion Store #:
2560

7514 North Point Rd
Edgemere
MD
21219

04/04/2019

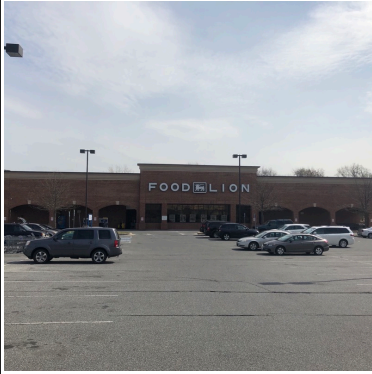
Deficiency Item #:	Deficiency Detail:	Correction:	Code:	Photo:	Quantity:	Unit:	Total:
Store Front	Store Front

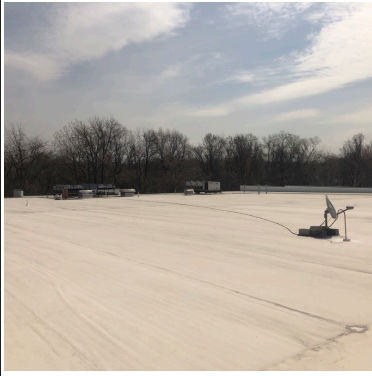
Item	\$0.00
Overview A	Overview

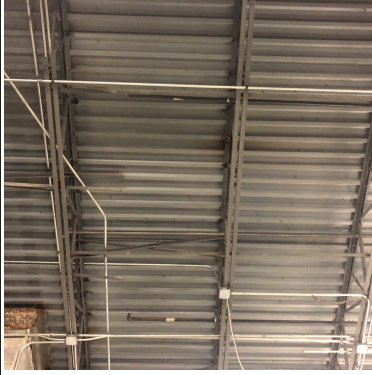
Item	\$0.00
Underside of Deck A	Deck

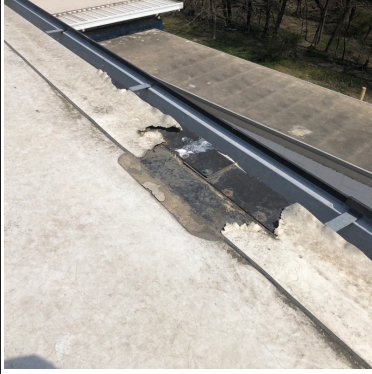
Item	\$0.00
Section A: 1	Edge flashing deteriorated.	Remove existing and install new 6" cover tape.	E

50	LF	\$1,000.00

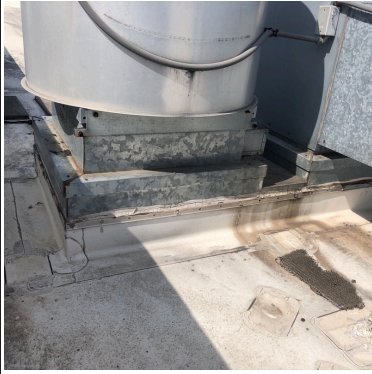
Deficiency Item #:	Deficiency Detail:	Correction:	Code:	Photo:	Quantity:	Unit:	Total:
Section A: 2	Deteriorated sealant to curb termination.	Remove existing materials and apply sealant.	C

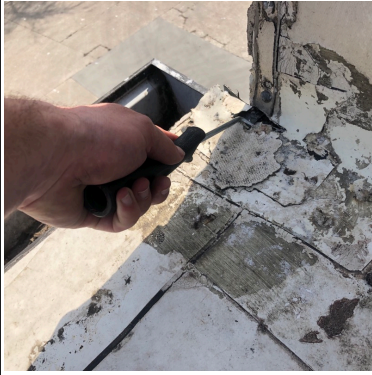
100	LF	\$500.00
Section A: 3	Hole on roof.	Remove existing and install membrane patch.	E

2	Item	\$200.00
