FOOD LION #2560 REVISED DRAIN SURVEY PER ENGINEERING REVIEW;
10/7/19 1/6/2019 - 10/14/2019

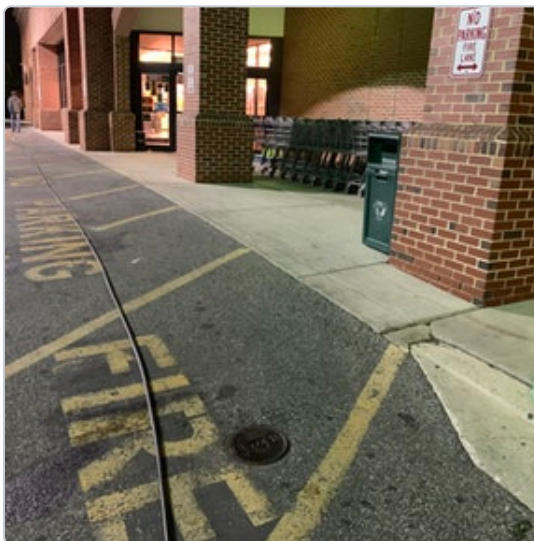
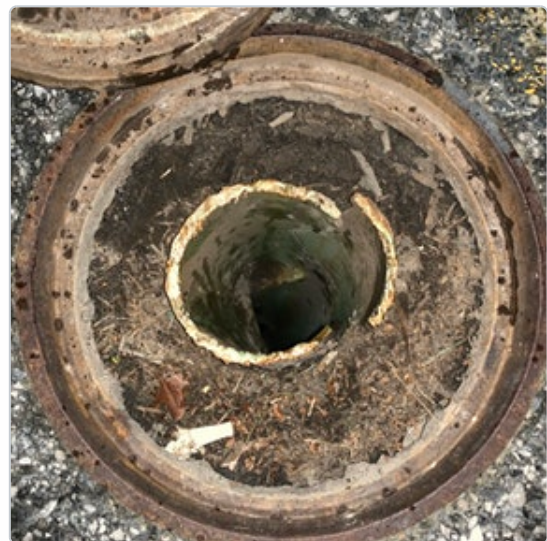
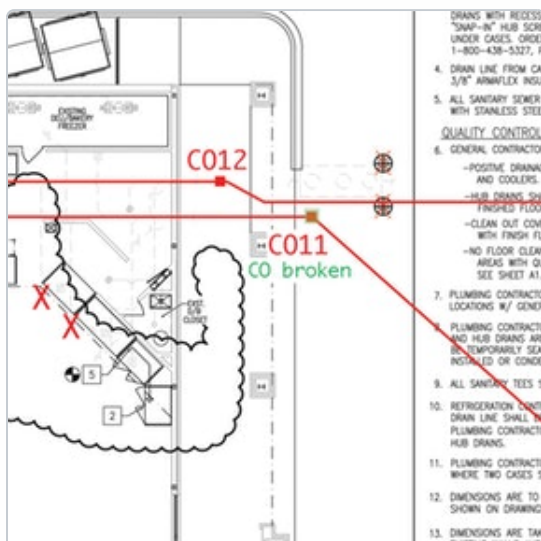
Post 15 - CO11 - Cleanout riser broken.

Riser was broken/bent prior to arrival. Repair recommended.

Per email from Food Lion Engineering on 10/7/19, item is to be included in remodel documents.

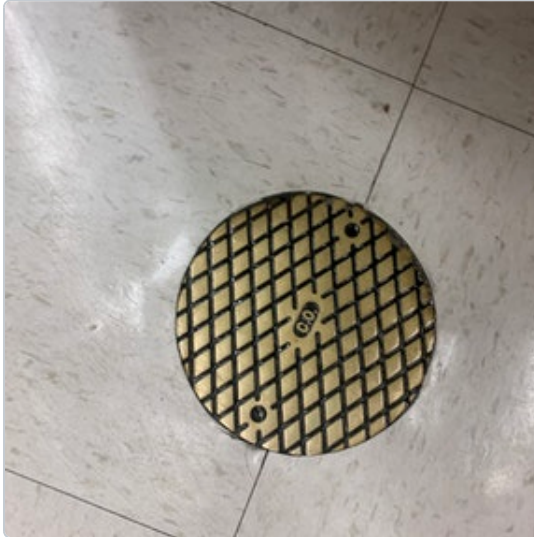
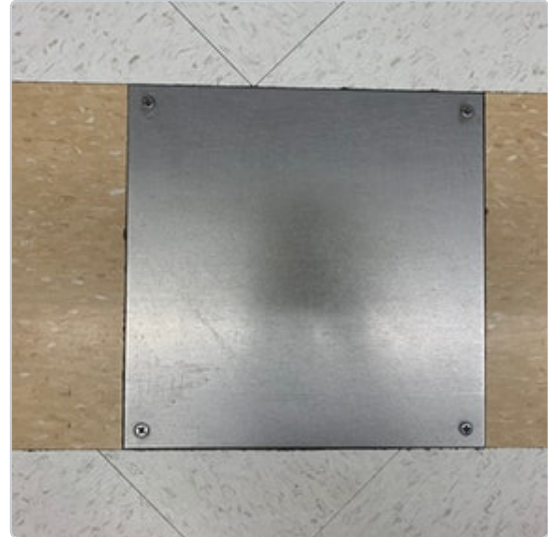
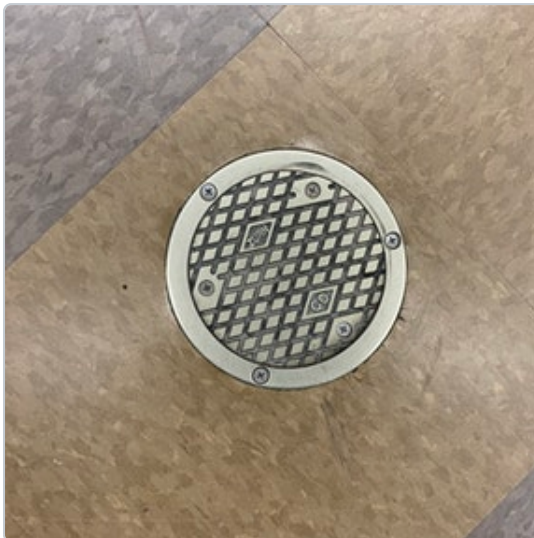
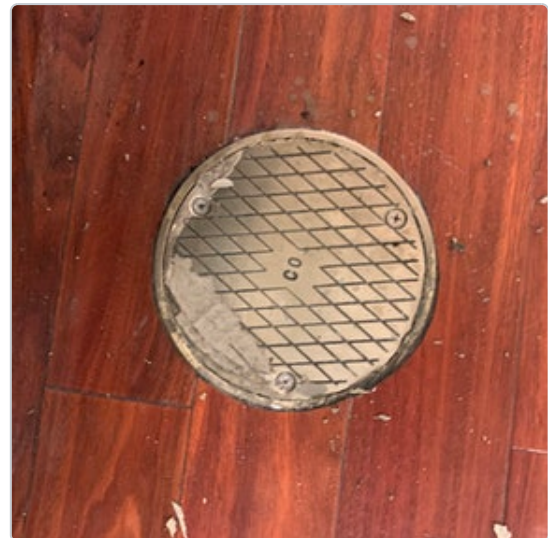
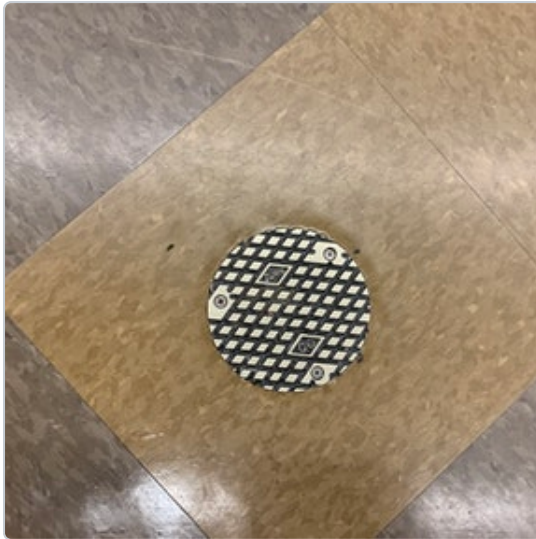
Unassigned**Post 4 - Construction Manager to review cleanouts for possible repair (for reference)**

The sales floor cleanouts typically have surrounding tile damage / unlevel / should be cleared of excess wax and debris. Ensure all are level with finish floor upon closeout of remodel. Consider replacing fixtures.

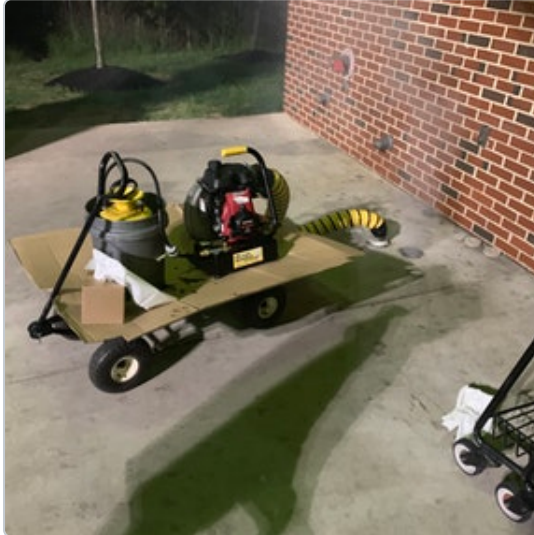
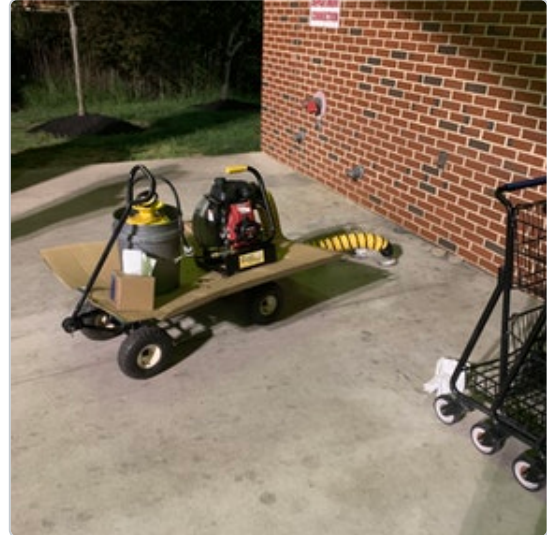
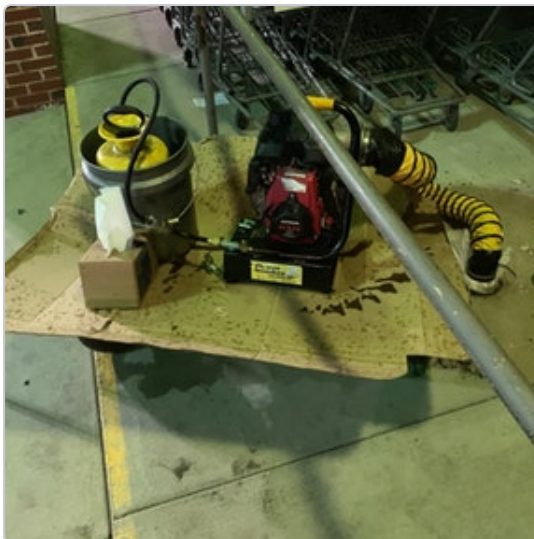
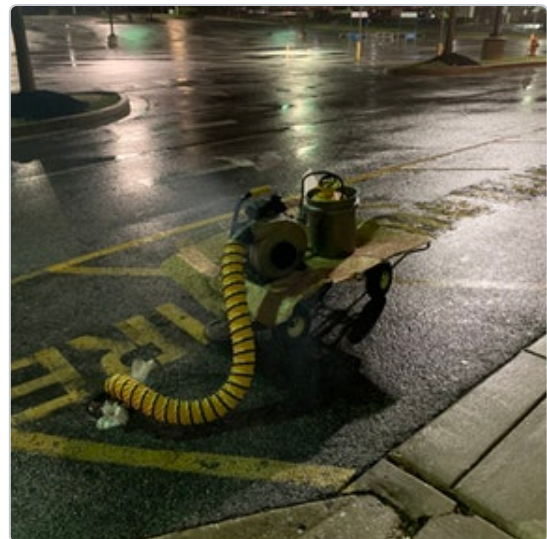
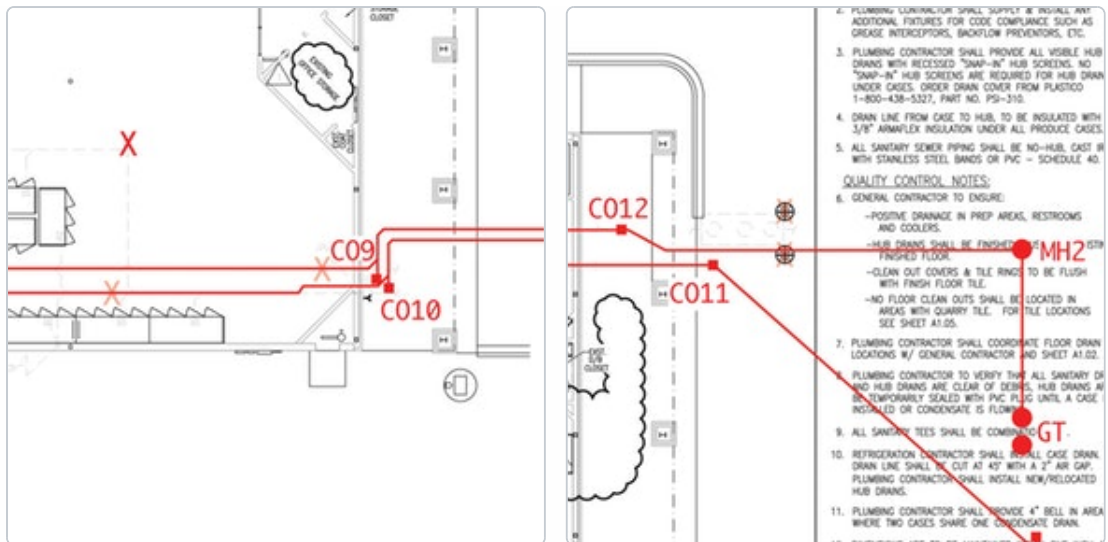
Post 7 - Smoke test showed no issues - 05/25/2019

Unassigned**Post 6 - Smoke test performed from cleanouts CO9, CO10, CO11 and CO12 - 5/25/2019**

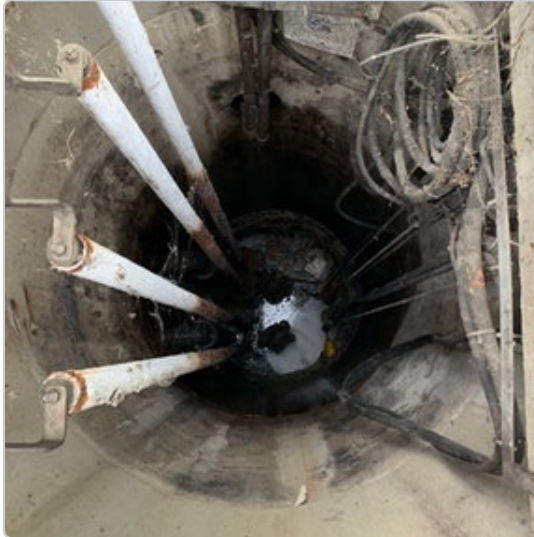
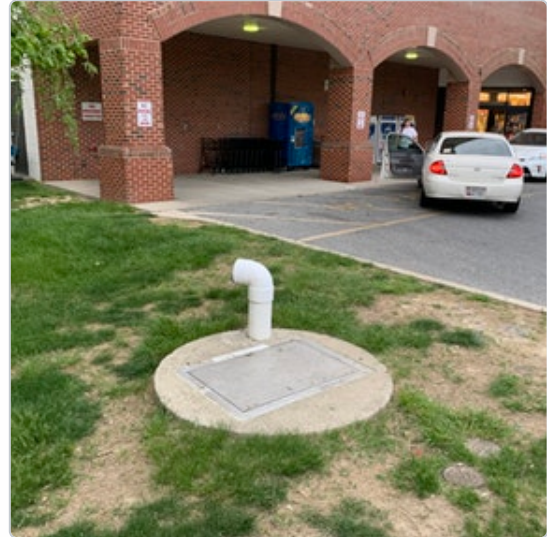
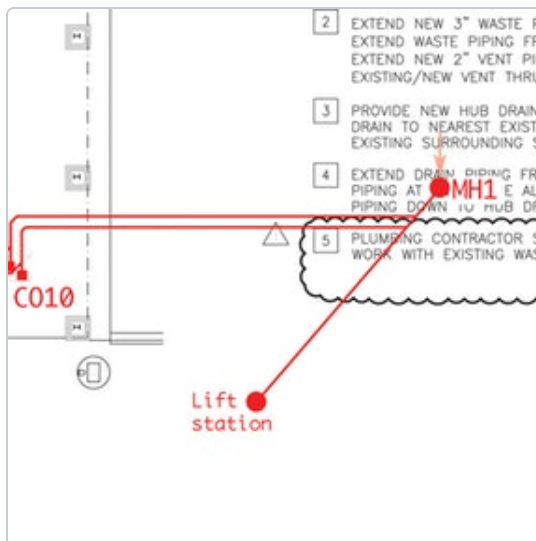
Unassigned**Post 14 - Lift station**

Appears to be functioning normally.

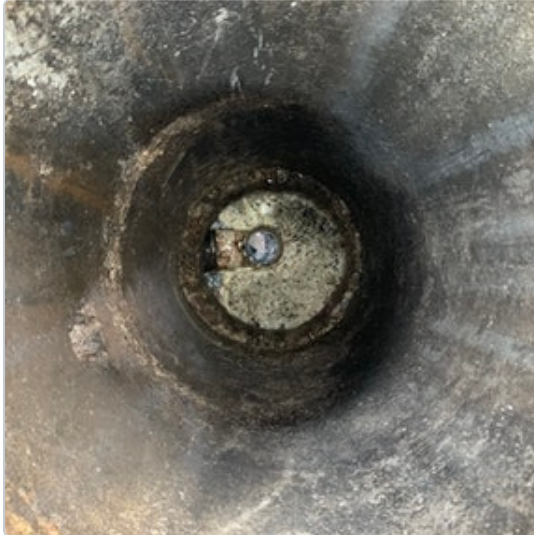
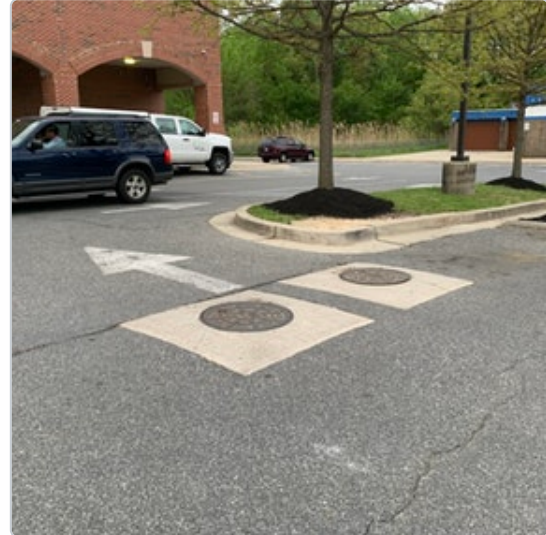
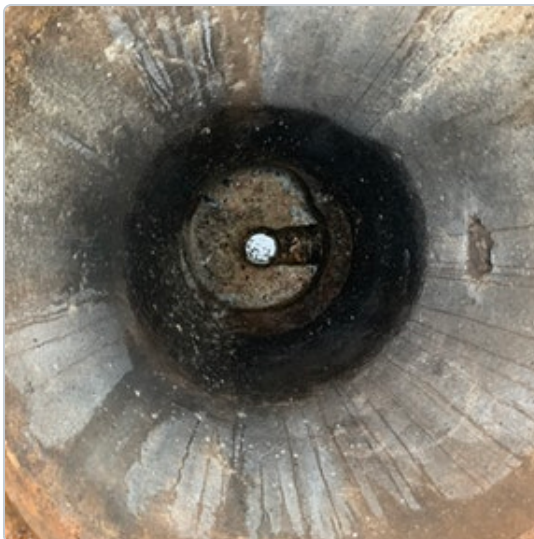
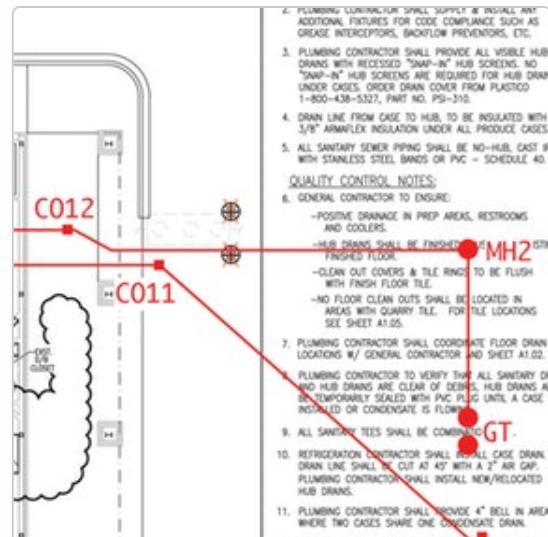
Post 9 - Grease trap - Appears to be functioning normally with inlet 1/2" above outlet.

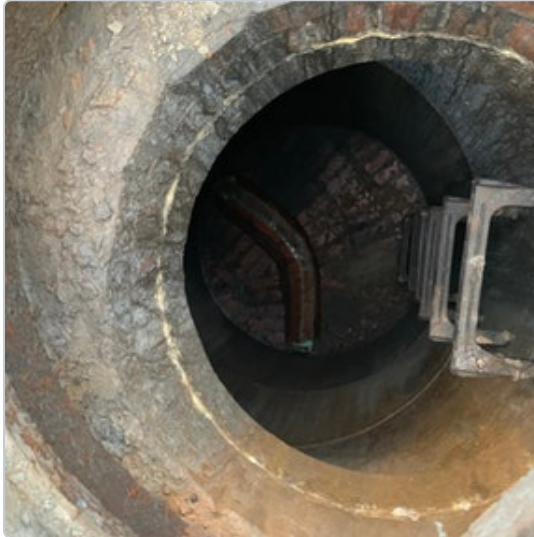
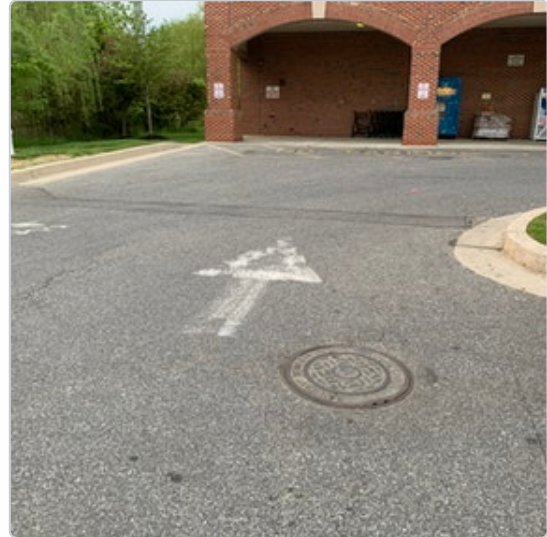
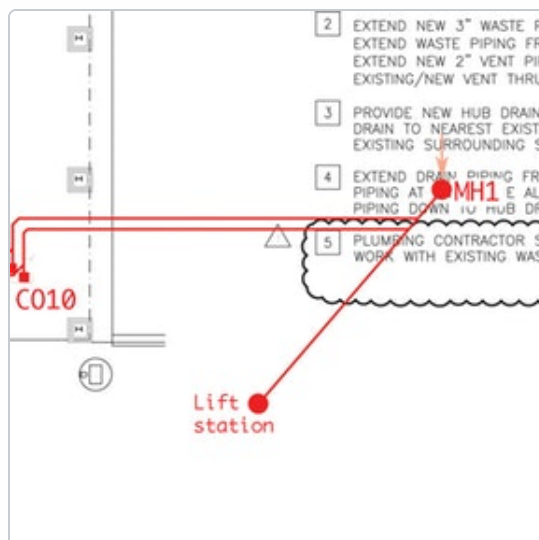
Unassigned**Post 8 - Manhole MH1**

Manhole is flowing/operating normally

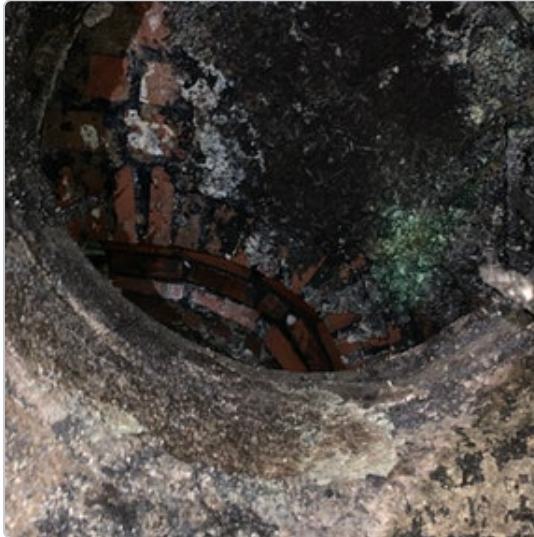
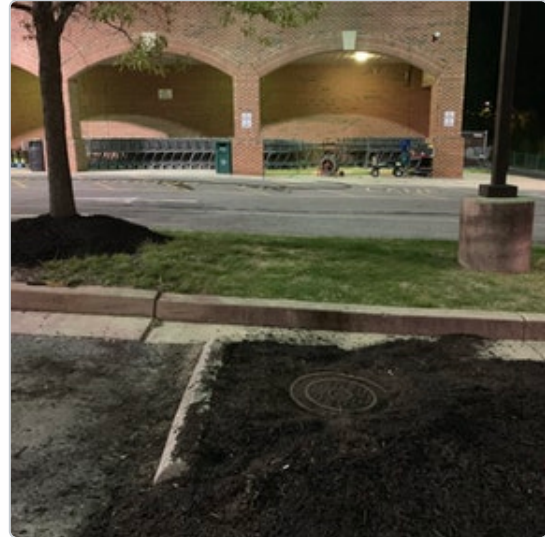
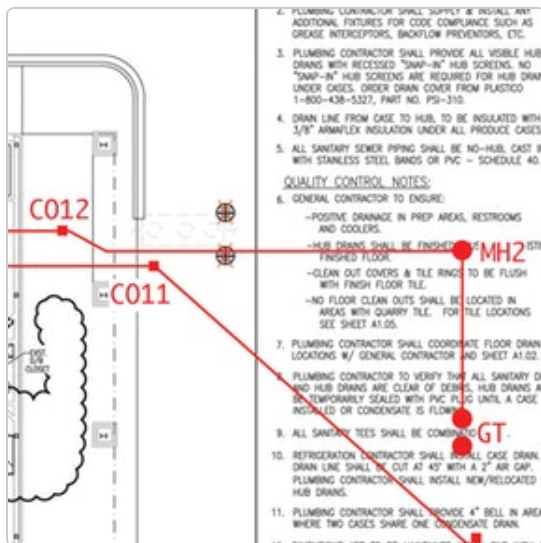
Unassigned**Post 16 - Manhole MH2**

Manhole is flowing/operating normally.

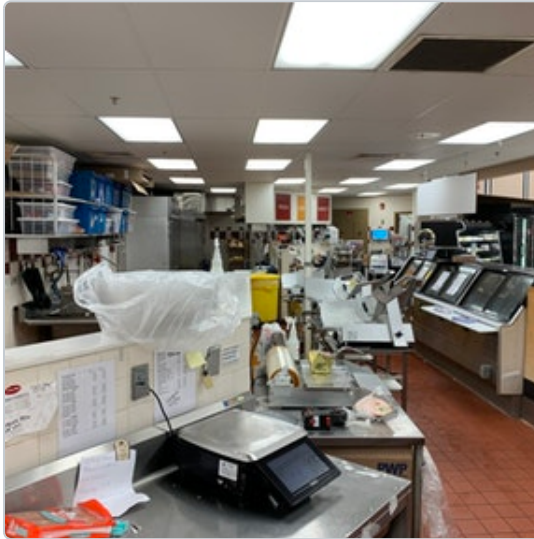
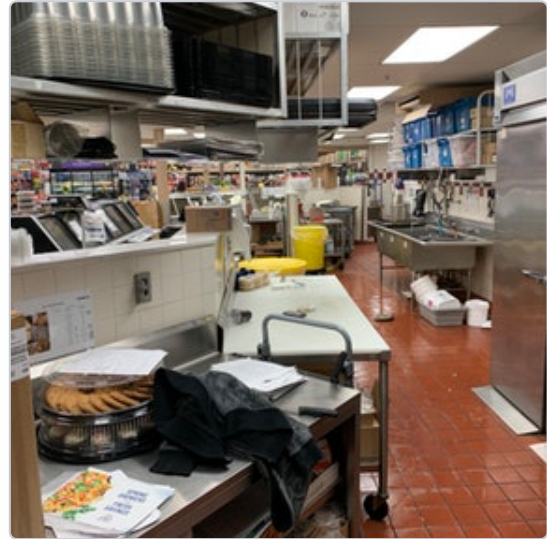
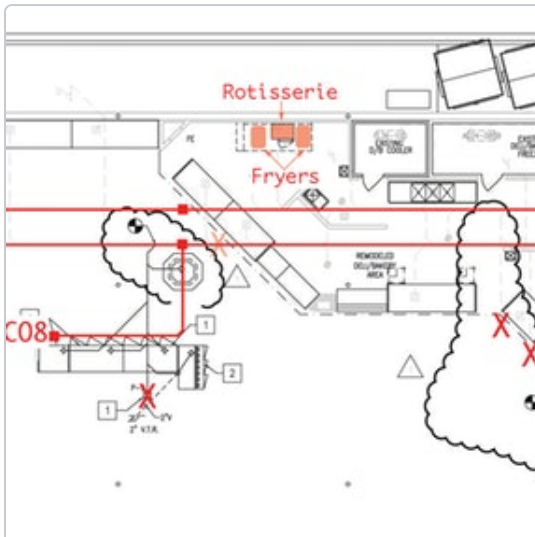
Unassigned**Post 13 - Deli grease drain - prep area verifications**

The deli prep area floor drains, prep sinks, and deli mop sink were confirmed to go to CO2 line.

All grease prep area sinks and drains were confirmed to go to the existing grease trap.

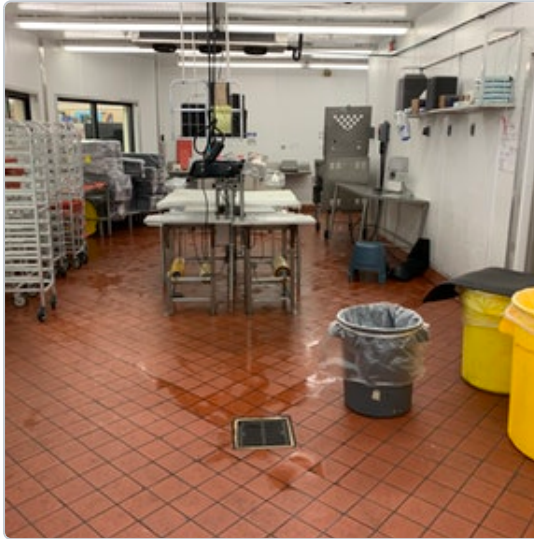
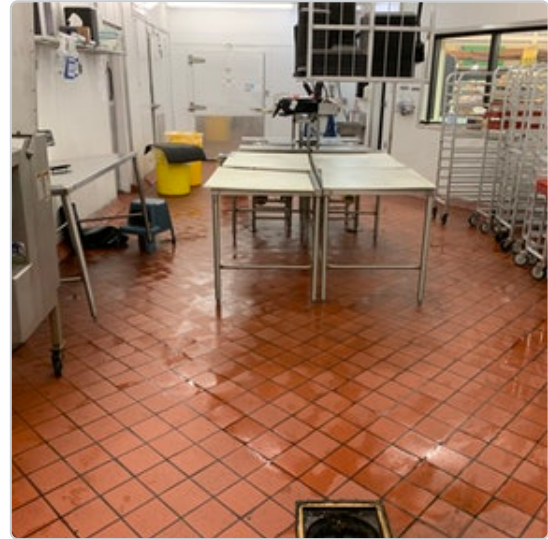
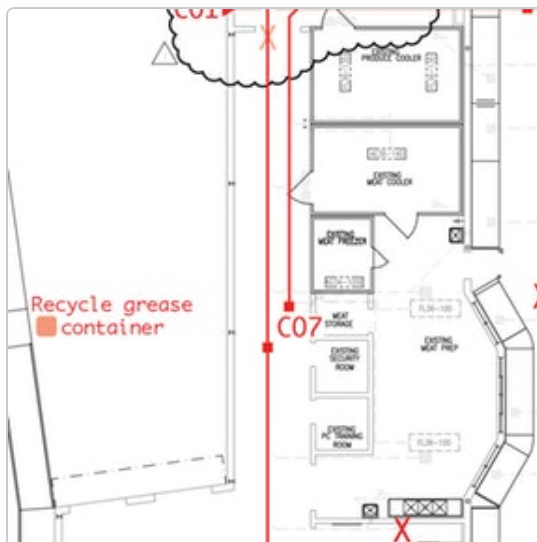
Post 12 - Meat grease drain - prep area verifications

The meat prep area floor drains, prep sinks, and grocery storage mop sink were confirmed to go to CO6 line.

All grease prep area sinks and drains were confirmed to go to the existing grease trap.

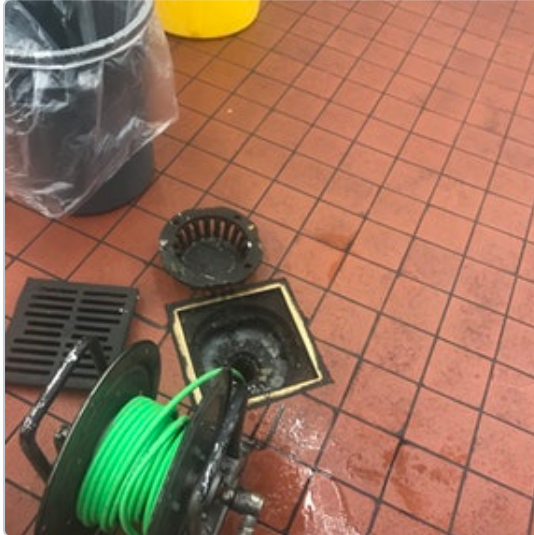
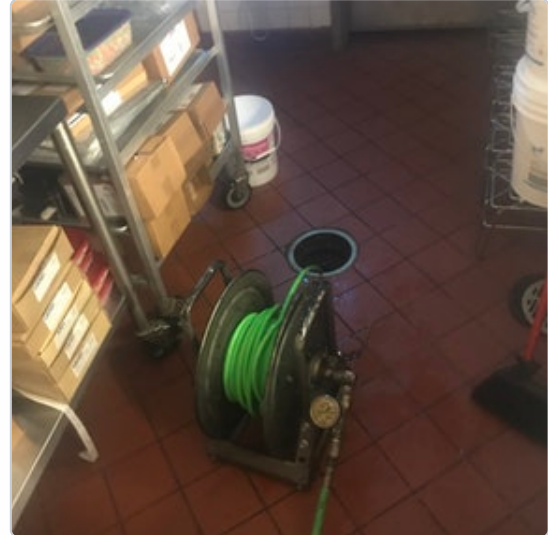
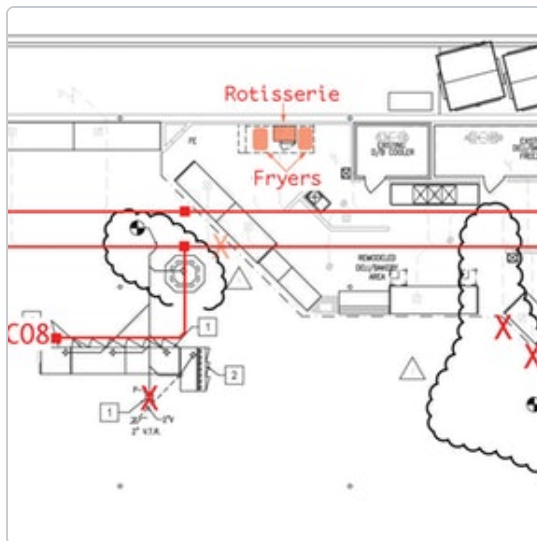
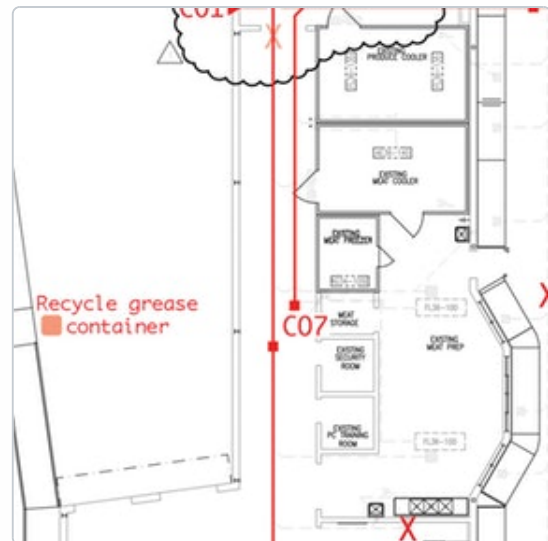
Post 10 - All individual prep area grease waste drains were cleaned with mini jet kit.

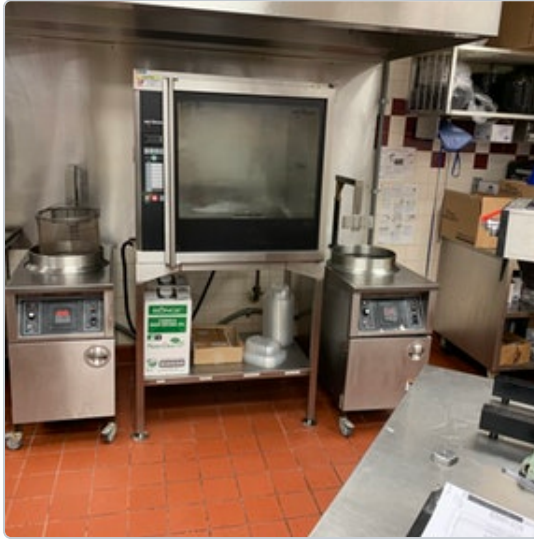
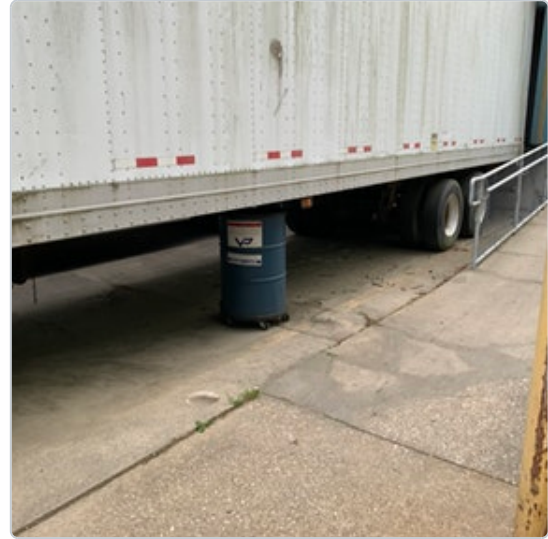
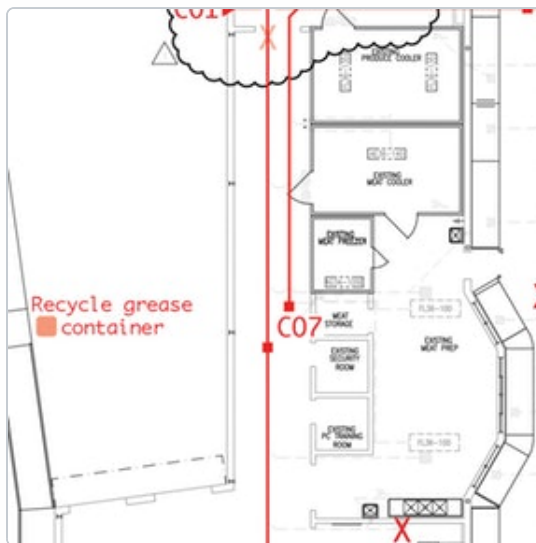
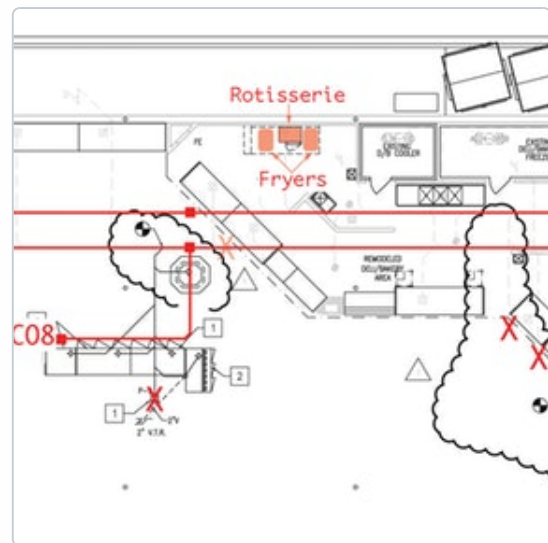
Unassigned**Post 11 - Deli Equipment**

Recycle grease container verified to be onsite.

Rotisserie and fryers appear to be manually emptied.

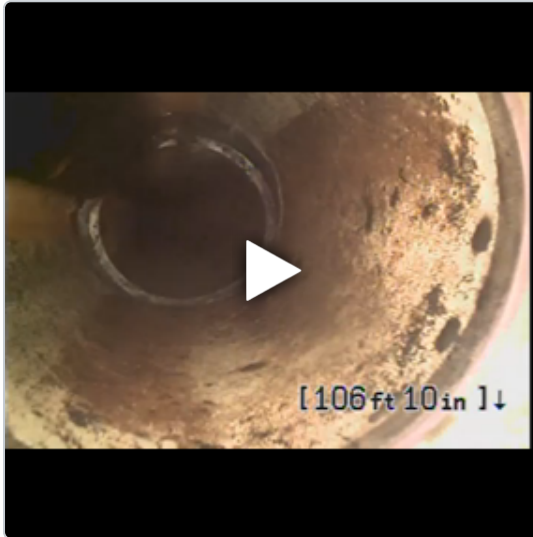
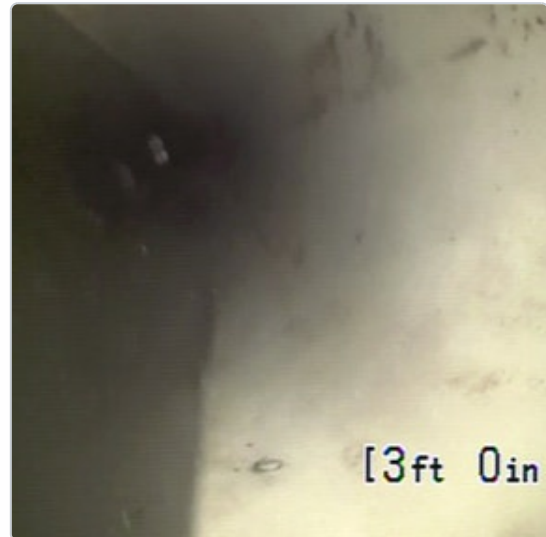
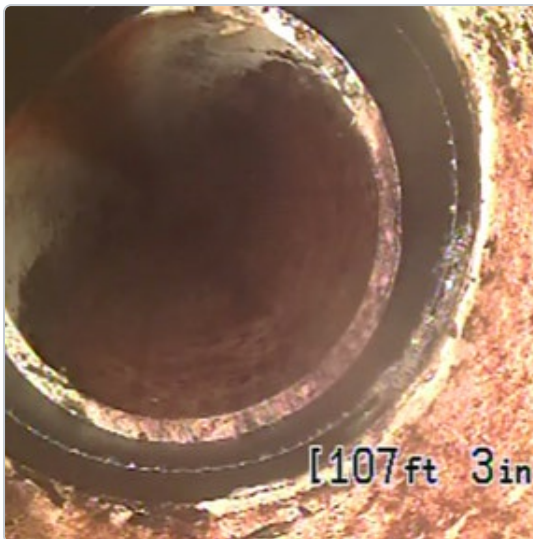
Unassigned**Post 1 - CO1 video (for reference)**

CO1 line: Invert elevation is 22.5" BFF. Filmed backwards from CO11. Sag from 2' to 10' (2"; with camera under water part of issue). Joint separation at 107'.

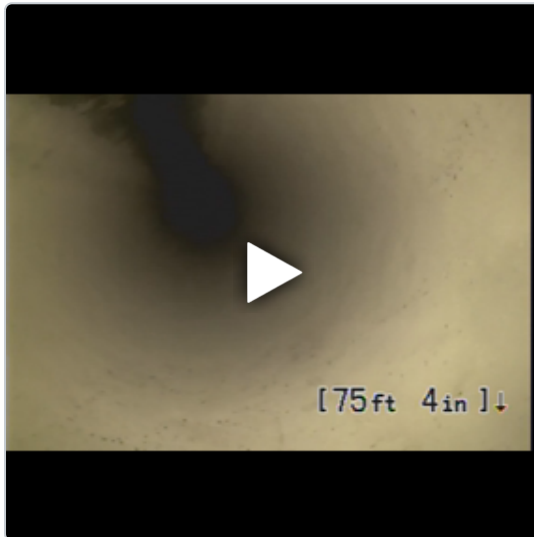
**Unassigned****Post 17 - CO2 video (for reference)**

CO2 line: Invert elevation is 39" BFF. Jetted line. Filmed backwards from CO12.
Line in good shape.

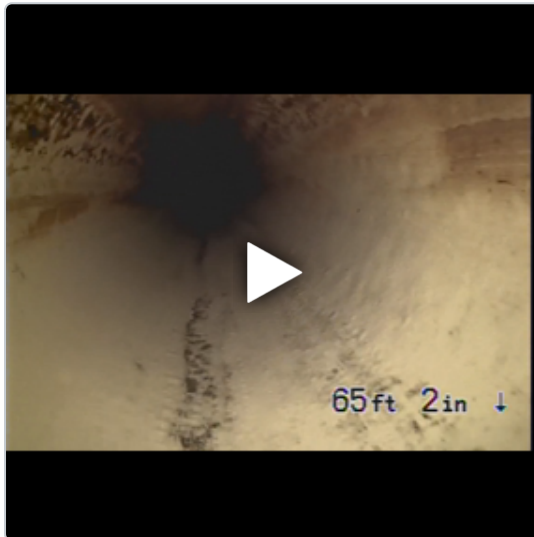
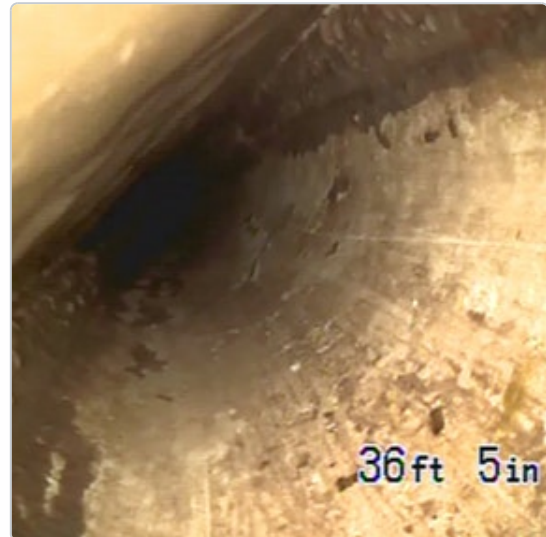
**Unassigned****Post 18 - CO3 video (for reference)**

CO3 line: Invert elevation is 28" BFF. Filmed backwards from CO9 line. Sag from 35' to 44' (1").

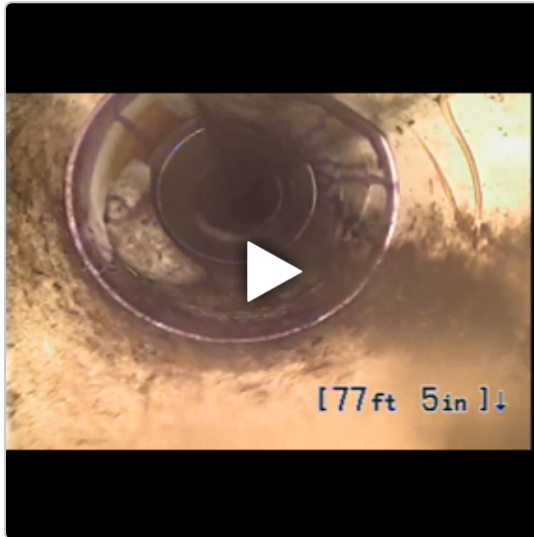
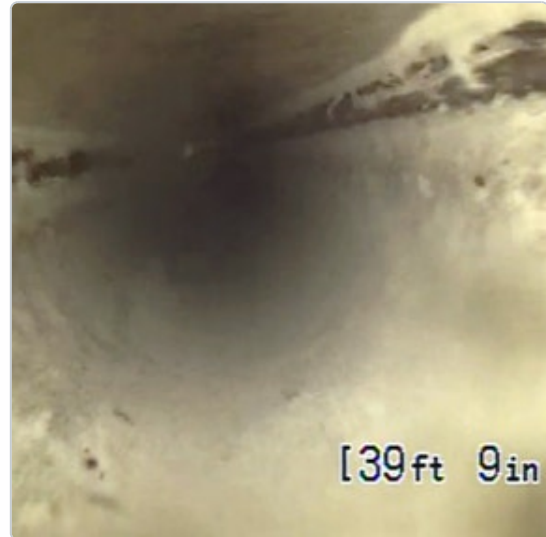
**Unassigned****Post 19 - CO4 video (for reference)**

CO4 line: Invert elevation is 33.5" BFF. Filmed backwards from CO10. Sag from 36' to 41' (0.5").

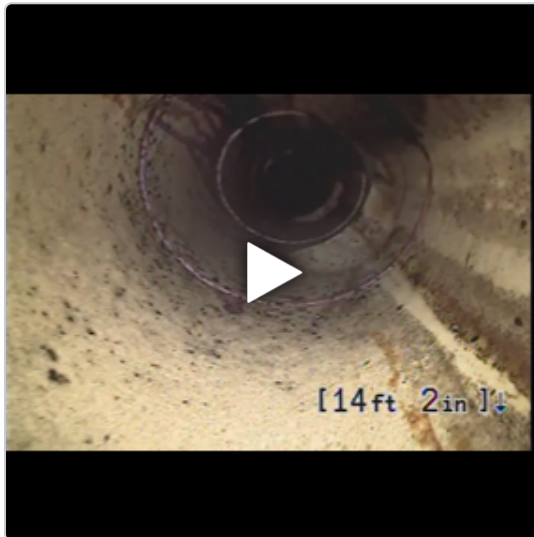
**Unassigned****Post 20 - CO5 video (for reference)**

CO5 line: Invert elevation is 33.75" BFF. Filmed backwards from CO4 line. Line in good shape.

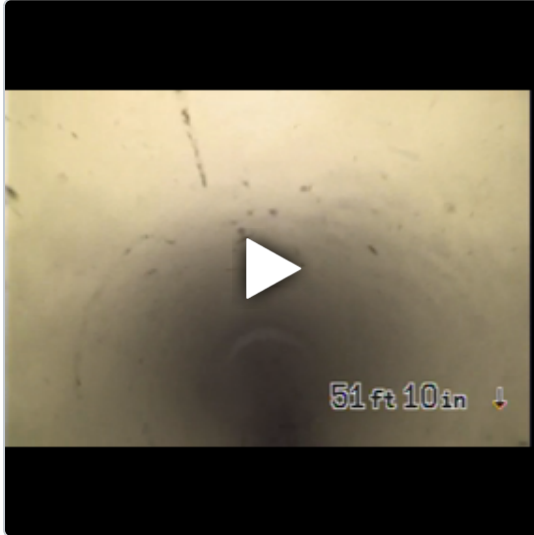
**Unassigned****Post 21 - CO6 video (for reference)**

CO6 line: Jetted line. Filmed backwards from CO2 line. Line in good shape.

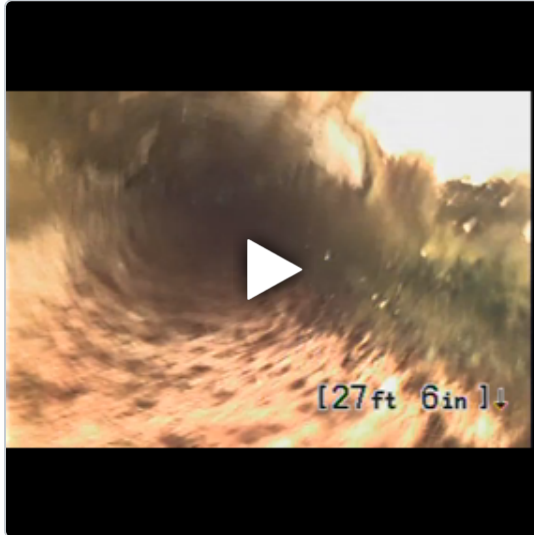
**Unassigned****Post 22 - CO7 video (for reference)**

CO7 line: Invert elevation is 20" BFF. Filmed backwards from CO1 line. Line in good shape.

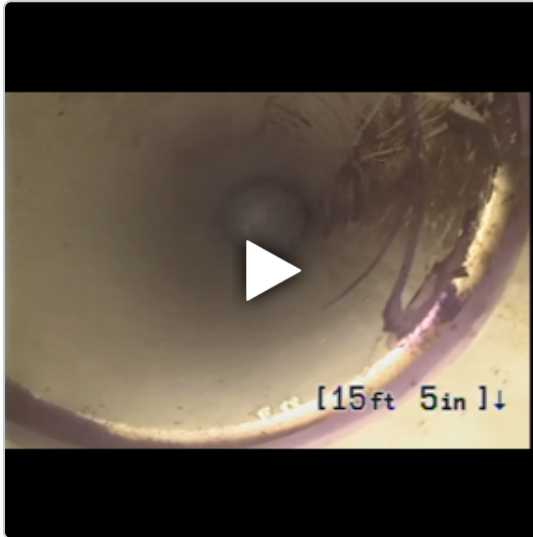
**Unassigned****Post 23 - CO8 video (for reference)**

CO8 line: Invert elevation is 7" BFF. Filmed backwards from CO1 line. Line in good shape.

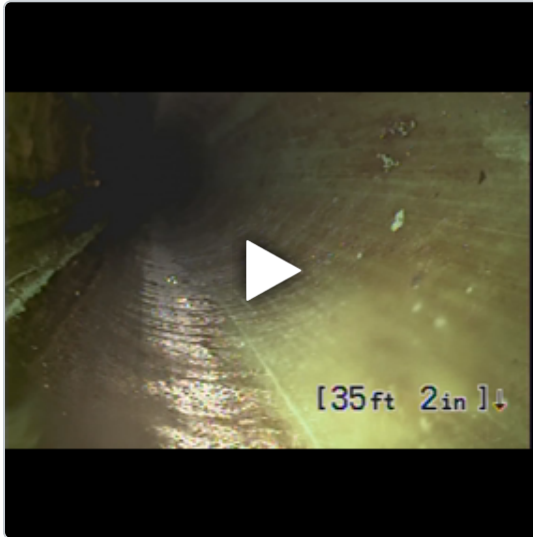
**Unassigned****Post 24 - CO9 video (for reference)**

CO9 line: Invert elevation is 55.5" BFF. Filmed backwards from lift station. Line in good shape.

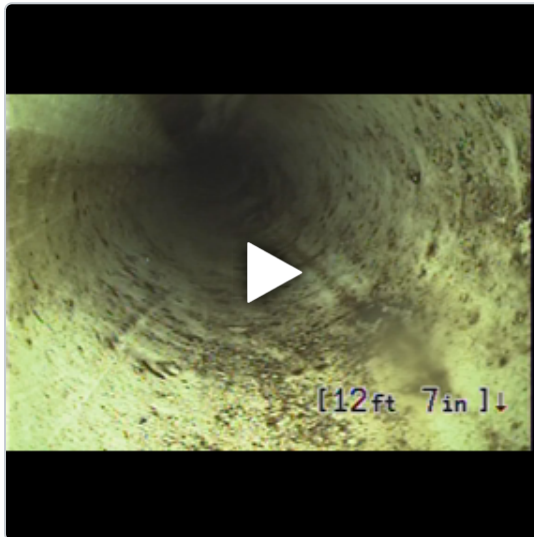
**Unassigned****Post 25 - CO10 video (for reference)**

CO10 line: Invert elevation is 57.25" BFF. Filmed backwards from CO9 line. Line in good shape.

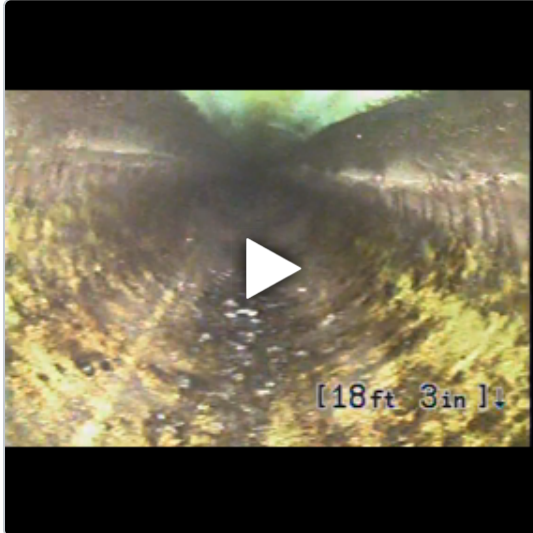
Unassigned**Post 26 - CO11 video (for reference)**

CO11 line: Filmed backwards from site line. Line in good shape.
