FOOD LION #1458 REVISED DRAIN SURVEY PER ENGINEERING REVIEW;
6/6/19 5/30/2018 - 6/6/2019

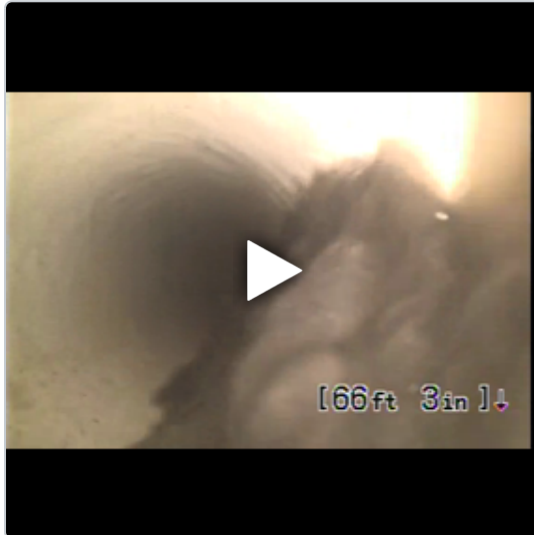
**Unassigned****Post 26 - CO1 video (for reference)**

CO1 line: Invert elevation is 30.5" BFF. Jetted line. Filmed backwards from CO11. Two back-to-back sags from 55' to 117' (2"+, with camera underwater most of issue). Sag from
