**FOOD LION #1653 REVISED DRAIN SURVEY PER ENGINEERING REVIEW;**  
**10/7/19** 1/6/2019 - 10/14/2019

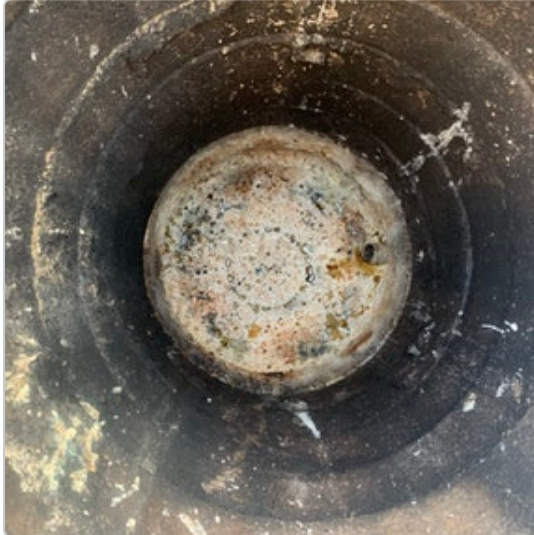
**Post 9 - Grease trap - Appears to be functioning normally with inlet 1/2" above outlet.**

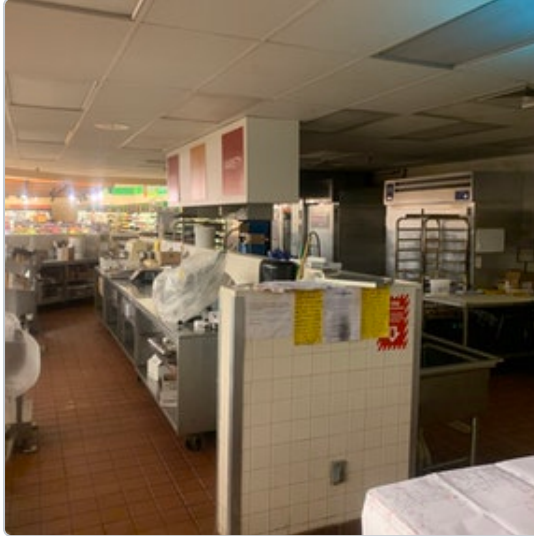
Unassigned**Post 13 - Deli grease drain - prep area verifications**

The deli prep area floor drains, prep sinks, and mop sink were confirmed to go to CO14 line.

All grease prep area sinks and drains were confirmed to go to the existing grease trap.

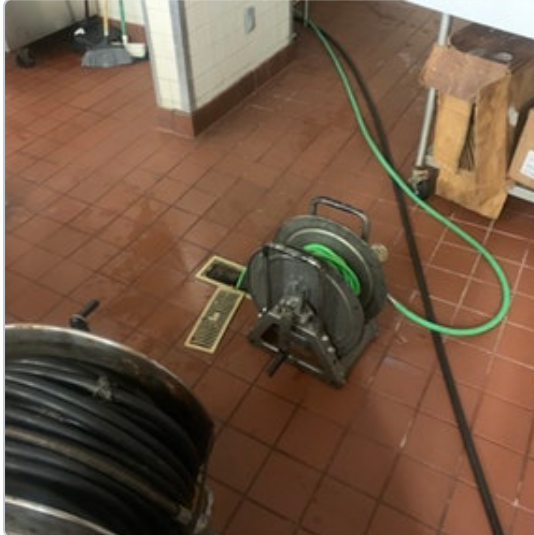
**Post 10 - All individual prep area grease waste drains were cleaned with mini jet kit.**

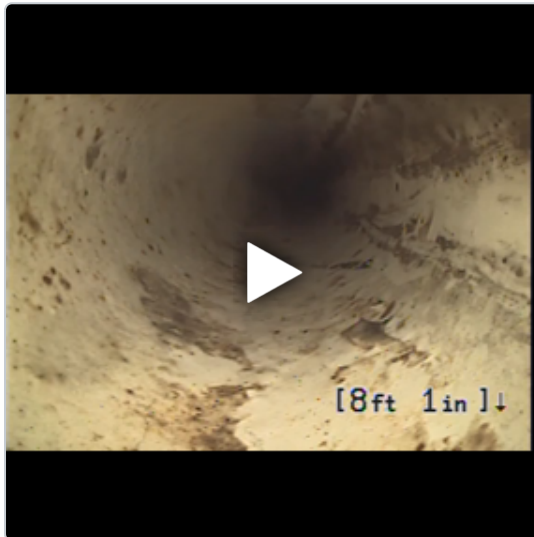
**Unassigned****Post 32 - CO1 video (for reference)**

CO1 line: Invert elevation is 19.25" BFF. Filmed backwards from CO2 line. Line in good shape.

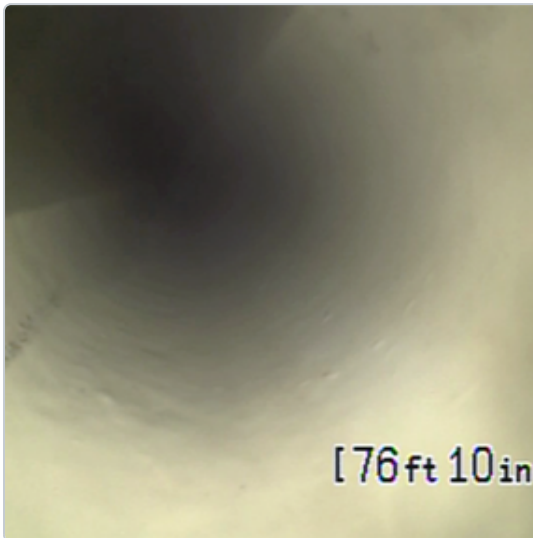
Unassigned**Post 31 - CO2 video (for reference)**

CO2 line: Invert elevation is 20" BFF. Jetted line. Filmed backwards from CO12 line. Back-to-back sags from cleanout to 99' (generally 1"+ up to 2", with camera underwater part of issue).

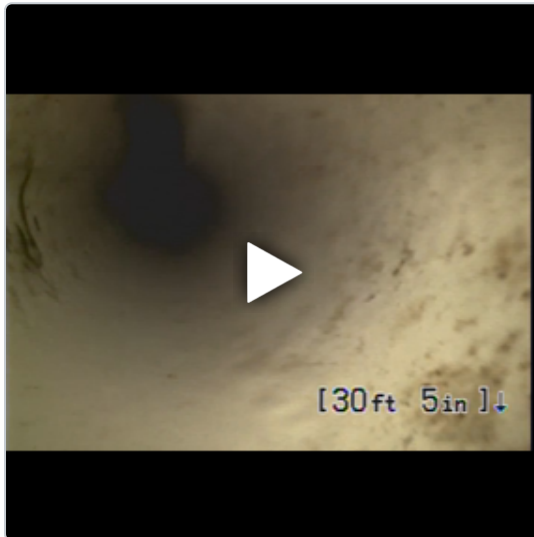
**Unassigned****Post 30 - CO3 video (for reference)**

CO3 line: Invert elevation is 21.25" BFF. Filmed backwards from CO11 line. Line in good shape.
