Re: Asbestos Inspection Report  
Food Lion #1653  
1565 Hyde Park Rd  
Essex, MD 21221

Winchester Environmental Consultants Inc. (WECI) is pleased to submit this Asbestos Survey for the above referenced site. These services have been performed in accordance with our proposal dated February 21<sup>st</sup>, 2019.

## Food Lion 1653 Asbestos Sample Map

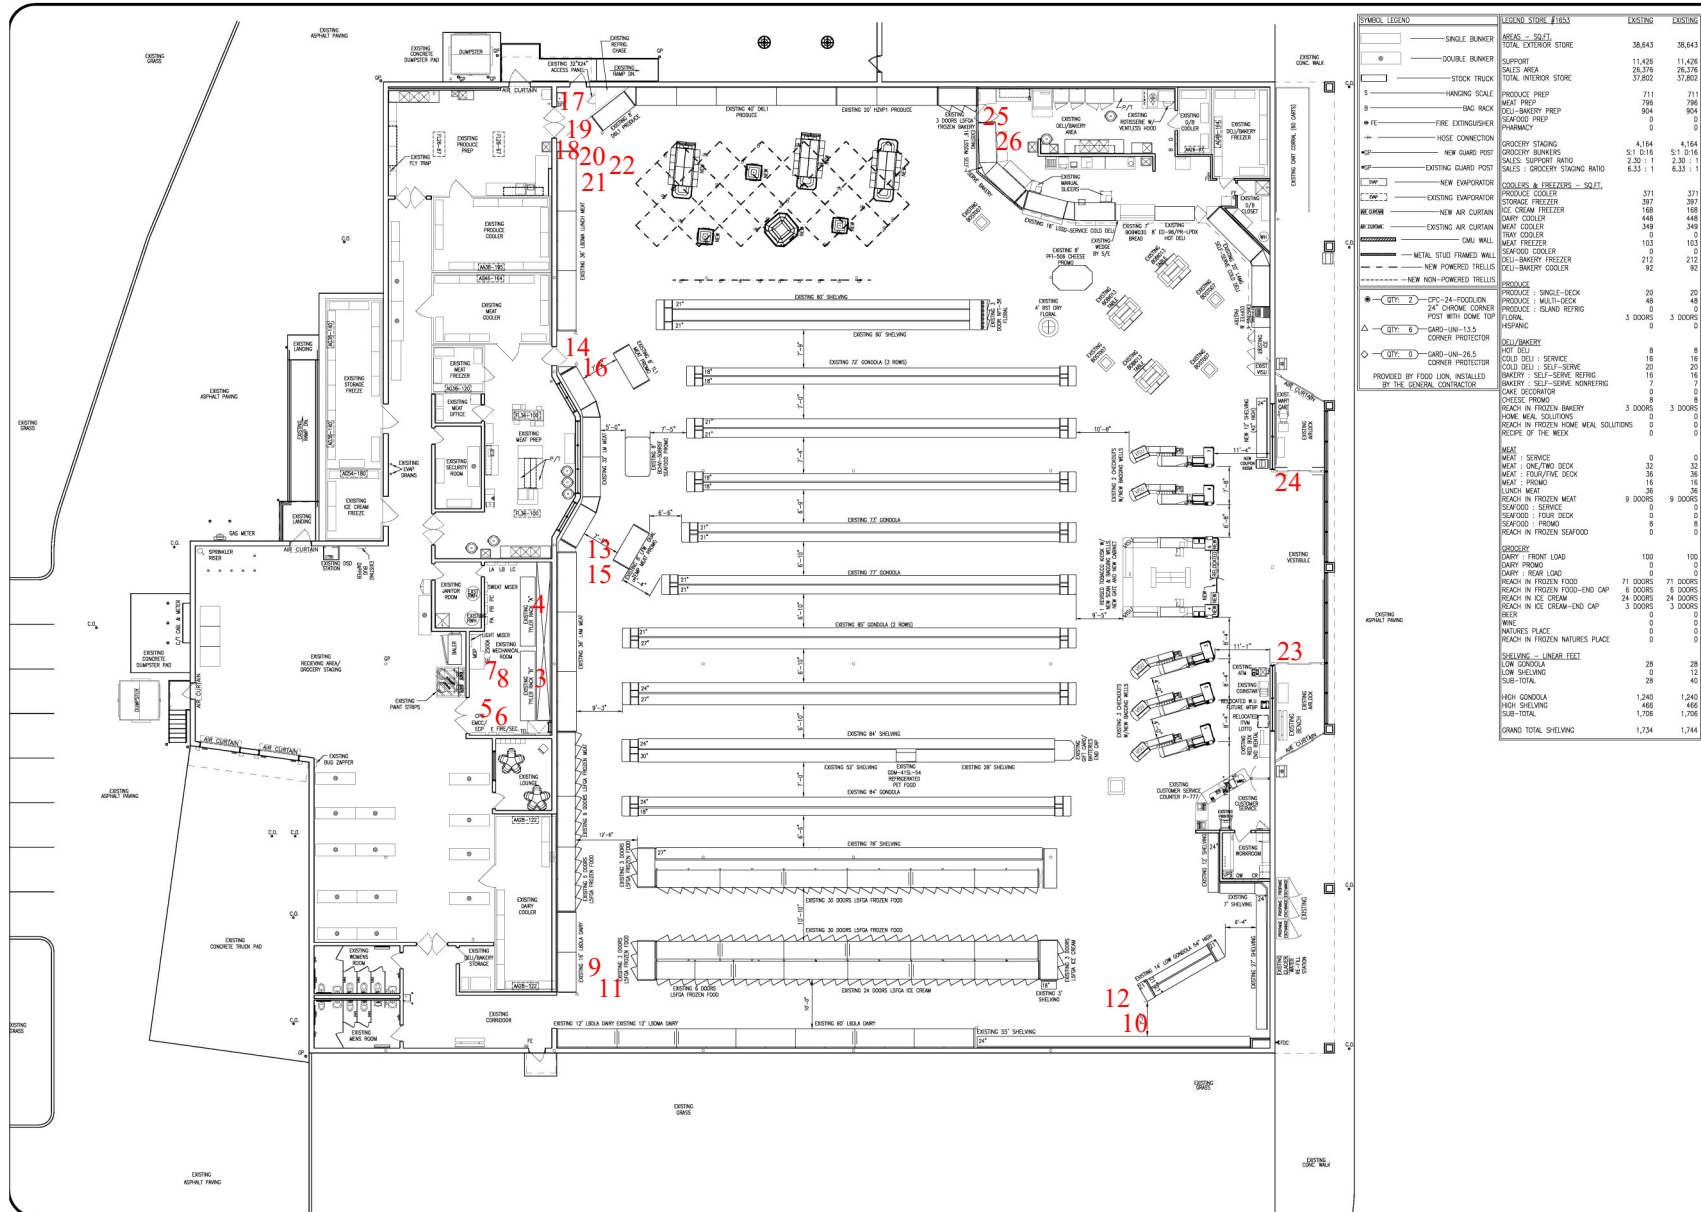
Materials identified and sampled in the study area of Store 1653 included drywall, drop ceiling tile, floor tile, roofing, and mastic (where applicable). The general construction of the store includes steel frame, rubberized membrane roof, concrete block, drywall and concrete floors with floor tile. Materials collected during this study and the associated laboratory analyses are detailed in the attached sample log.

**TABLE I**  
**ASBESTOS SAMPLE RESULTS**  
**Store # 1653**  
**Essex, MD**
